# Preliminary Information

## PIP5417A Diagnostic Tip - Oil Leak From Crankshaft Rear Oil Seal

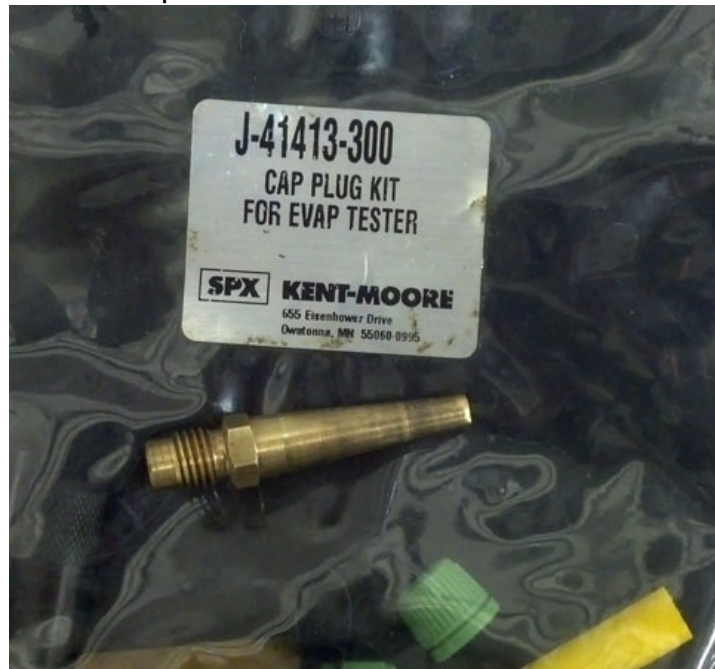
EEST hose adaptor.

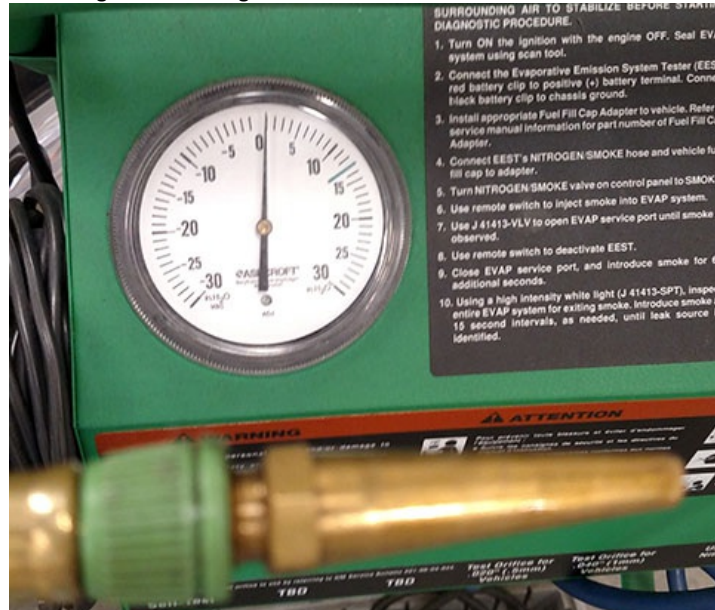
EEST Gage at 0 reading.

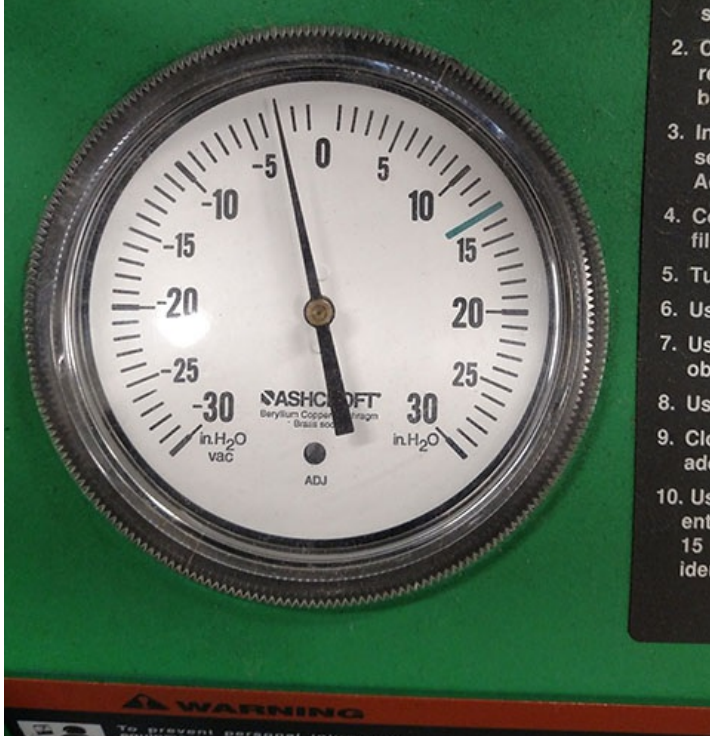
Normal crankcase pressure readings for the L3A, LE2 and LFV are between -1 & -5 inches of water in park at hot idle.

Normal crankcase pressure readings for the L3A, LE2 and LFV.

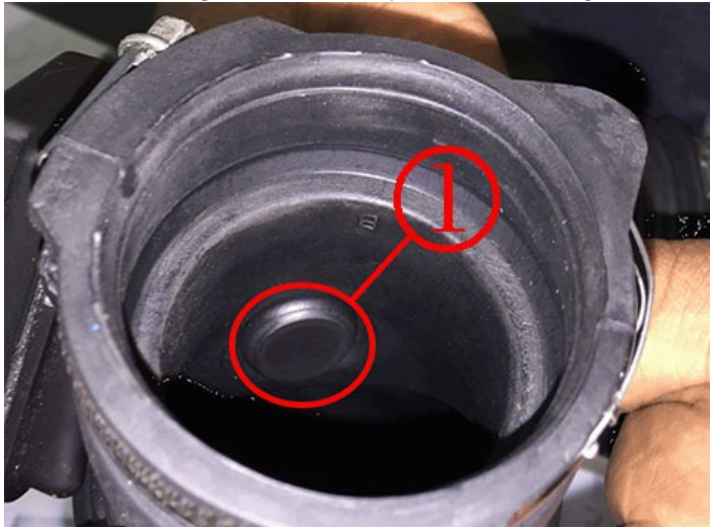
If the crankcase pressure is excessively negative, below -16 inches of water (-1 inches of HG / vacuum) then a negative crankcase pressure concern exists requiring further diagnostics.

Inspect the Air Cleaner Outlet Duct for a blocked PCV fresh air port. (see picture below)

Air Cleaner Housing Outlet Duct with port closed causing excessive negative crankcase pressure.

If the port is not blocked, then replace the camshaft cover assembly and retest for proper crankcase pressure.
