PIT5487C Service Park Assist/Camera/Cruise/ and/or Front Park/Turn/Cornering Light Inop Blown Fuses (Front Fascia/Bumper Harness Chaffing)

Brand:	Model:	Model Years:	VIN:		Engine:	Transmissions:
			from	to		
Cadillac	Escalade Models	2015 - 2017	All	All	All	All

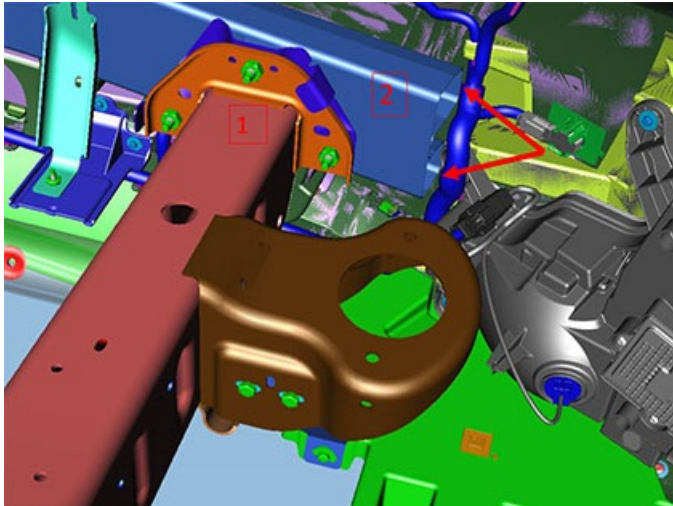
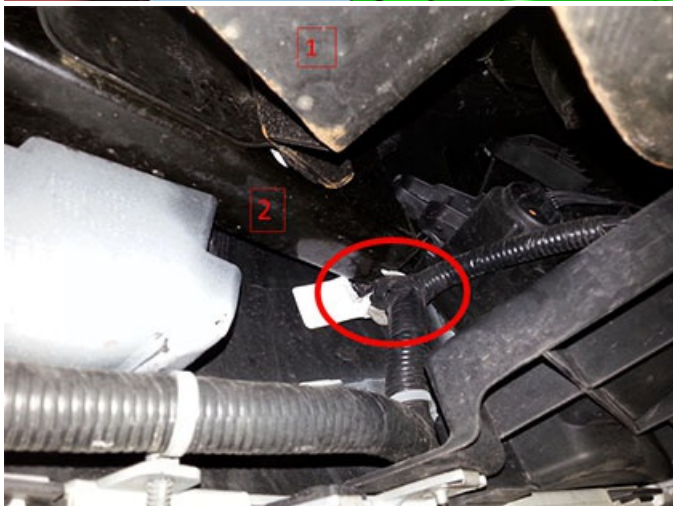
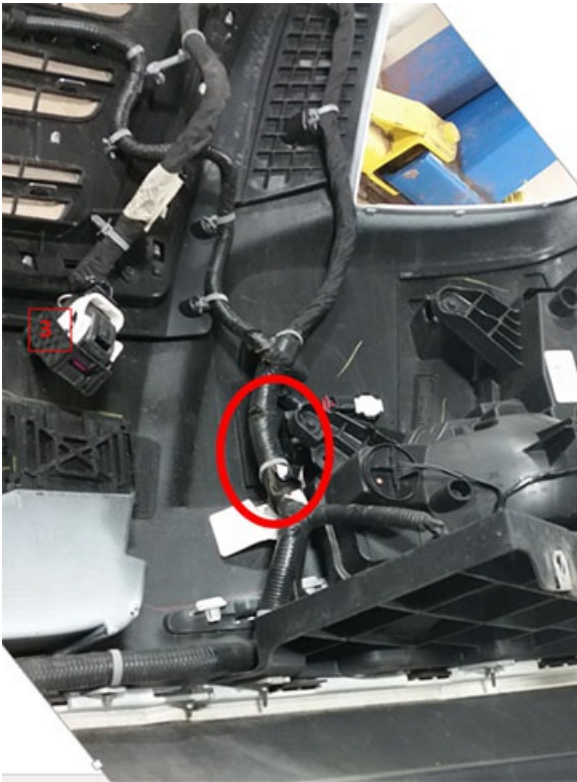
These concerns could be caused by the front fascia/bumper harness shorted at the end of the right front bumper bar (2), as shown below.

1. Right front frame rail
2. Right side of front bumper bar
3. X100 inline connector

The front fascia may need to be removed to make repairs to the wiring harness if any damage is found. After repairing any damaged circuits, reinstall the front fascia and pay close attention to reroute the wiring harness behind the front bumper bar and secure with a zip tie to the fascia, as shown below. This will prevent it from damage again in the future.
