**RECREATIONAL VEHICLE SERVICE CAMPAIGN**

**SERVICE ADVISORY 17-292**

### MORryde Zero G Ramp Door Pulley

Service Advisory 17-292  
**MORryde Zero G Ramp Door Pulley Service Bulletin**

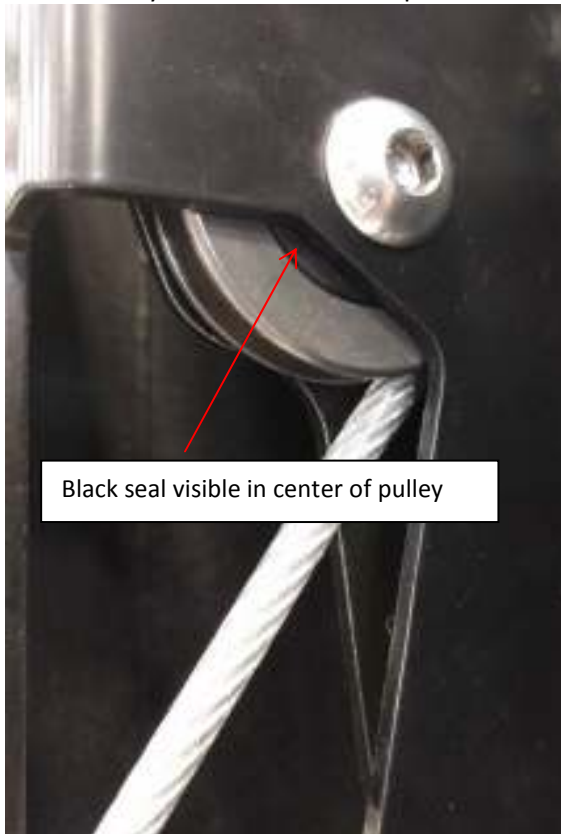
Pulley that Needs to be Replaced

Inspection: Look through the opening that the cable exits and inspect the pulley. Look for the black seal that is visible in the center of the pulley as shown in the pictures below. If the pulley does not have the seal, there is nothing further that needs to be done. If the pulley has the black seal and was manufactured during the date range, the cable and pulleys need to be replaced. Follow the instructions on the next page to do this.
