LTB00696NAS6

TECHNICAL BULLETIN

501-12: Instrument Panel and Console

Sunglasses Holder Will Not Open/Close

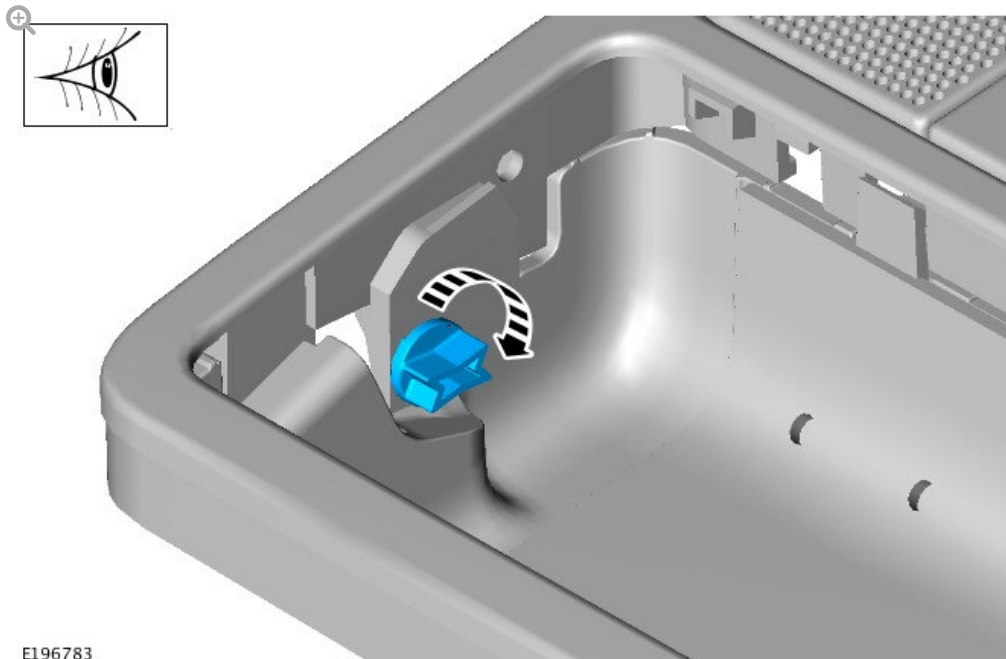
E196783

Rotate the cam latch through 360 degrees while visually inspecting it for possible damage.

- If the cam latch is not damaged, go to Step 10.
- If the cam latch is damaged or missing, go to Step 7.

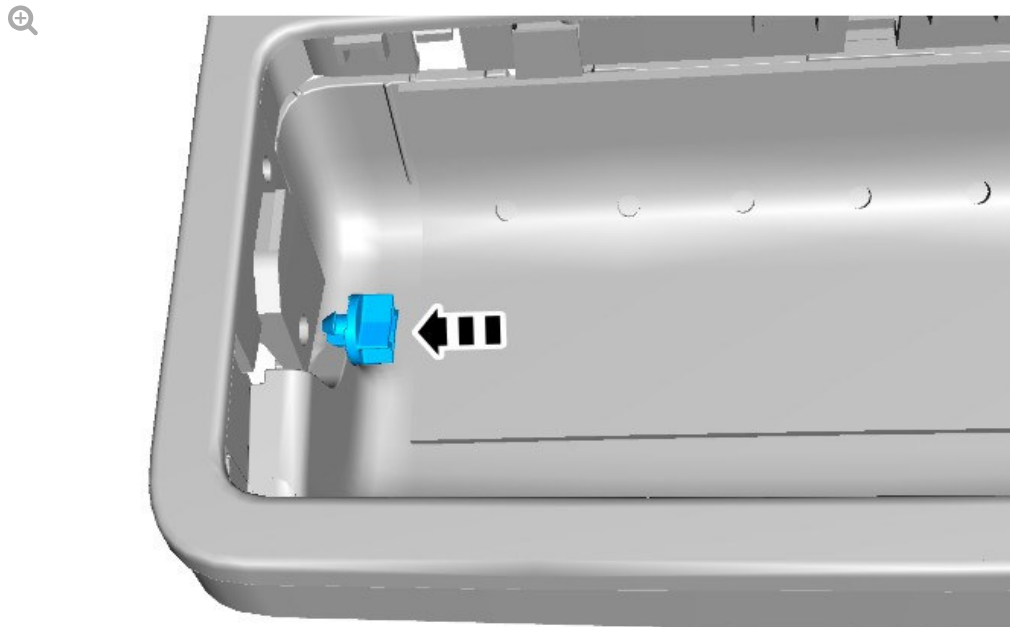
E195899

Make sure the overhead console frame is not damaged or distorted before/after installation.

Apply a small amount NyoGel® 774L grease to the cam latch hole in the front overhead console frame and install a new cam latch.
