DAS (Display Audio Smartphone Link) Part Number Inspection

DATE: June 2, 2017

AFFECTED VEHICLES: Certain 2017 Lancer SAM & 2017 Outlander Sport SAM

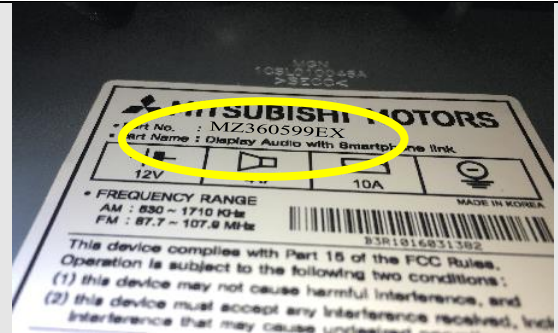
4. The 2017MY Lancer SAM correct part number is MZ360599EX.

- **OK** = Go to step 6.
- **NG** = Call Techline @ (800) 446-6064 for additional instructions. Then go to step 5.

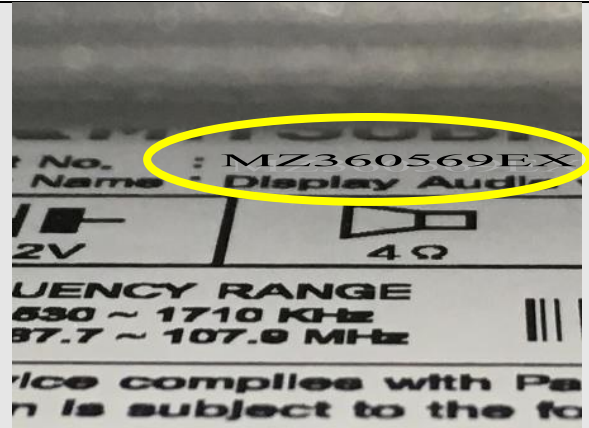
5. The 2017MY Outlander Sport correct part number is MZ360569EX.

- **OK** = Go to step 7.
- **NG** = Call Techline @ (800) 446-6064 for additional instructions. Then go to step 6.
