Technical Service Bulletin

SUBJECT:		No: TSB-17-42A-001	
LOWER LIFTGATE PANEL RUST – REVISED		DATE: June, 2017	
		MODEL: 2011 – 2015 Outlander Sport/RVR	
CIRCULATE TO:	<input type="checkbox"/> GENERAL MANAGER	<input checked="" type="checkbox"/> PARTS MANAGER	<input checked="" type="checkbox"/> TECHNICIAN
<input checked="" type="checkbox"/> SERVICE ADVISOR	<input checked="" type="checkbox"/> SERVICE MANAGER	<input checked="" type="checkbox"/> WARRANTY PROCESSOR	<input type="checkbox"/> SALES MANAGER

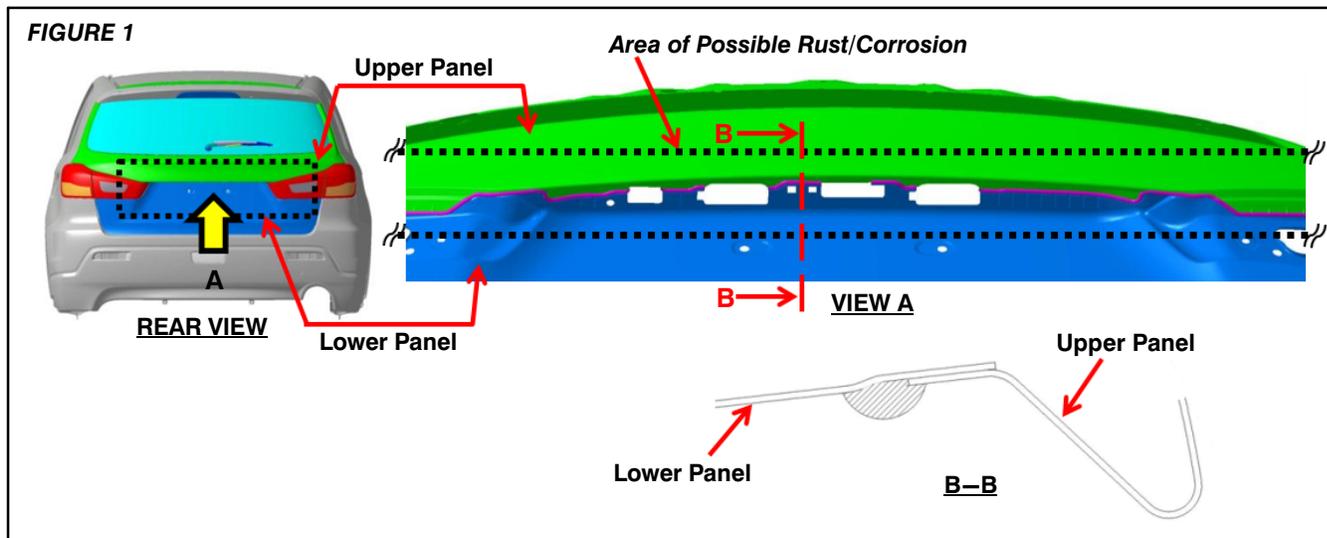
Customers of some affected vehicles may report rust or corrosion on the rear liftgate in the following areas:

- Section where liftgate upper panel meets the lower panel.
- Edge of the liftgate open switch on the lock release handle.

Rust between the upper and lower panels may be due to uneven sealant application that allows water to enter between the packing and the body sealant. Rust near the liftgate open switch may be due to inadequate clearance between the switch and upper panel, causing the edge of the switch to scratch the coating of the upper panel, leading to water intrusion and rust.

1. Take photographs of ALL rusted areas on the tailgate panel. See Figure 1 above for location of area(s) to be photographed.
2. Upload the photographs to the Photo Required Condition System (PRC). Post photos as Repair Type "Rust/Perforation Corrosion."
