Reference	SSM73376
Models	Discovery Sport / L550 LR2 / L359 Range Rover Evoque / L538
Title	L538, L550 & L359 12MY Onwards 2.0 GTDi - Coolant leak from Radiator
Category	Engine
Last modified	21-Jun-2017 00:00:00
Symptom	402000 Cooling System Concerns
Attachments	Radiator Spacer.png (Radiator Spacer.png)

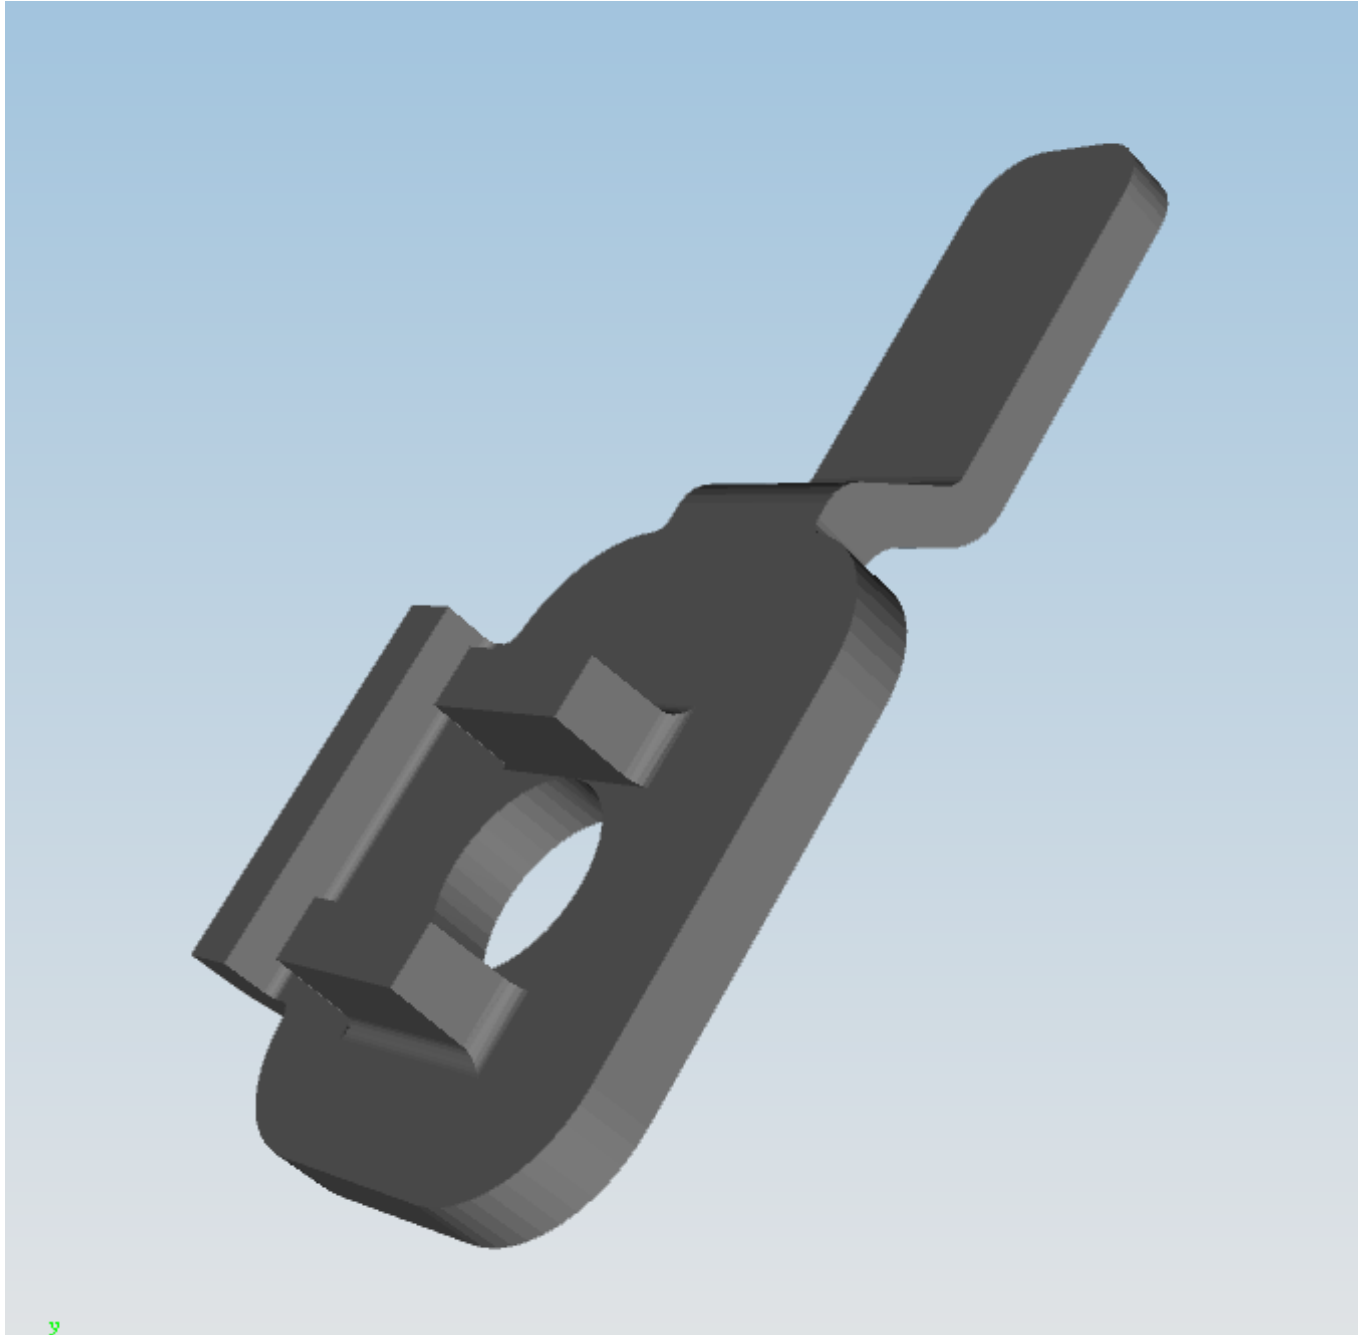
On inspection, the coolant leak is from the radiator.

Due to the rigid fixing of the radiator and the charge air cooler as thermal expansion and contraction occurs a crack may be induced on the radiator.

Image of spacer attached for reference.

When installing a new radiator a spacer (LR096114) must be installed as instructed in the recently updated workshop manual (Topix section 303-03B).
