Reference	SSM73239
Models	LR3 / L319 Range Rover / L405 Range Rover Sport / L320 Range Rover Sport / L494
Title	Engine Oil Level Sensor Concerns V6/V8 Diesel DTC P250A
Category	Engine
Last modified	26-Jun-2017 00:00:00
Symptom	Oil System Concerns
Attachments	Retainer Plate LR086422.pdf (Retainer Plate LR086422.pdf)

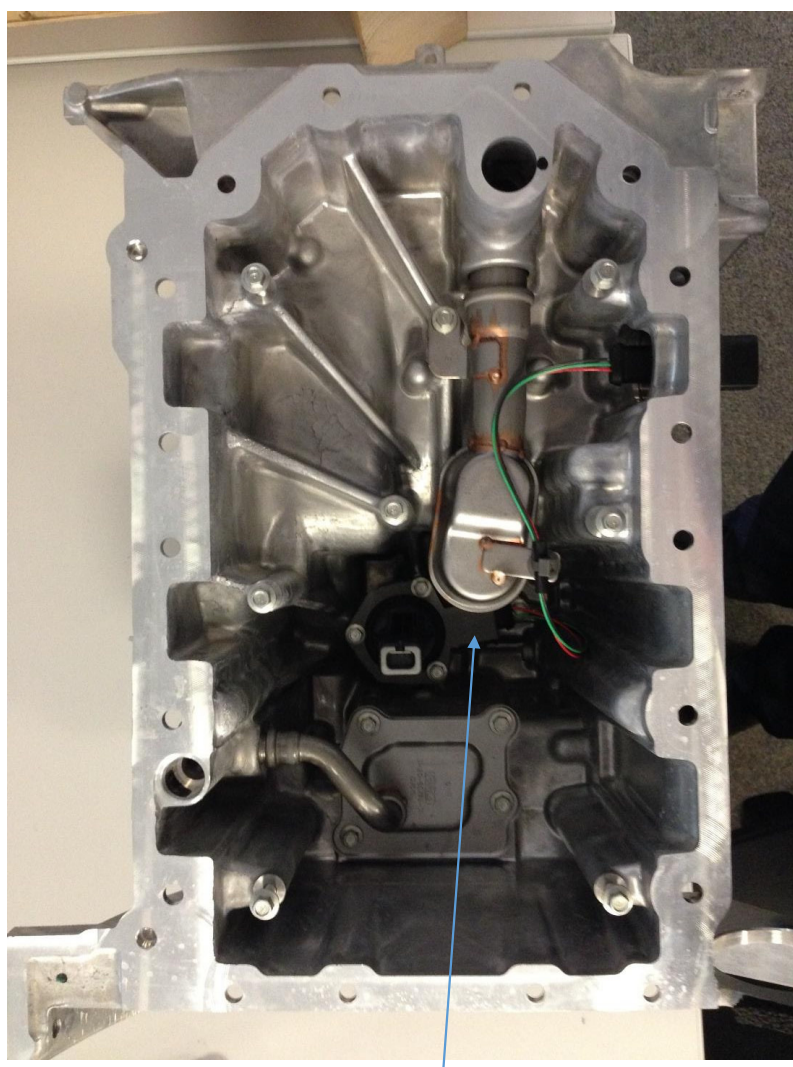
View down on top of oil pan with
windage tray removed

Retainer plate just visible

Action:
Fit revised fly lead and retaining plate internal to the oil pan to prevent the connector becoming disconnected, this will require oil pan removal (refer to TOPIx section 303: Engine – Oil Pan) . The three bolts holding the oil level sensor in place inside the oil pan will need to be removed, the new retaining plate (LR086422) can then be fitted over the existing oil level sensor and the three bolts refitted and torqued to 10Nm (refer to attached file for further details).

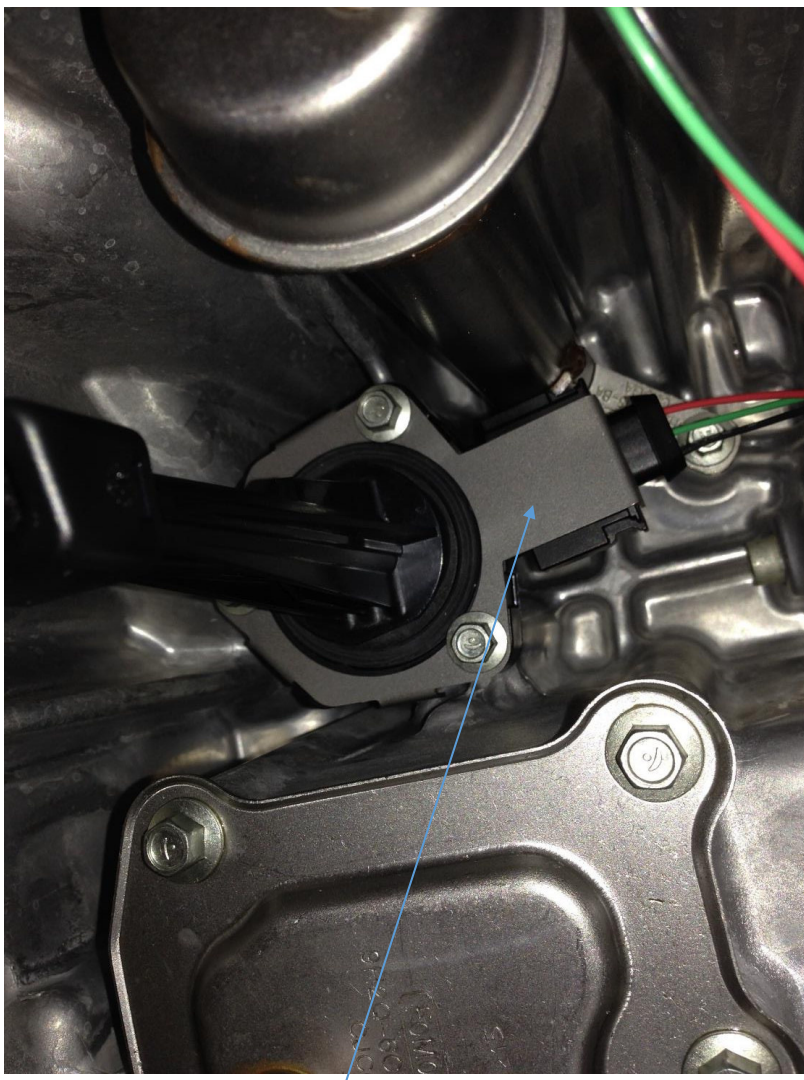
Close up of retainer plate in
place over the oil level sensor

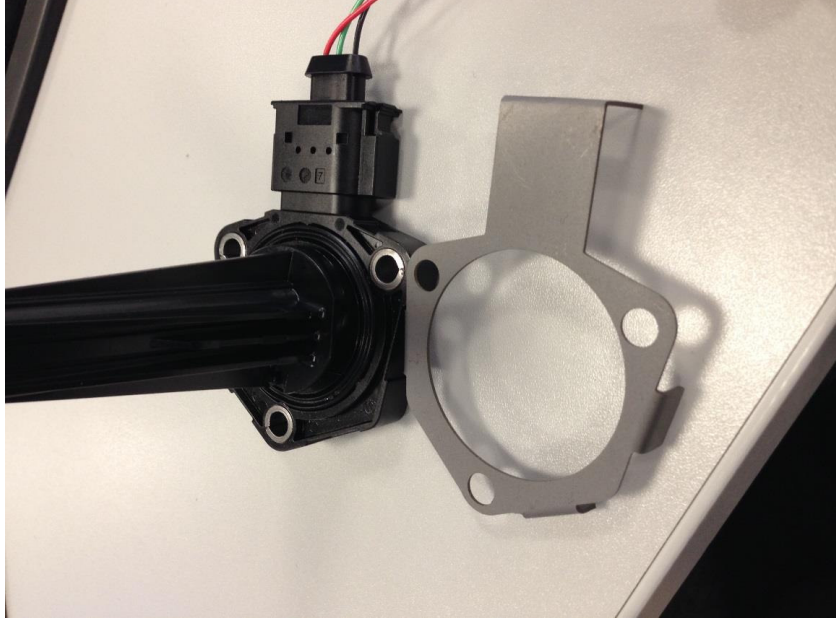
View of retainer plate with the oil level sensor behind it.
