Q649 UPS8316-5BNAS1

TECHNICAL BULLETIN

501-20A

Update Prior to Sale: Second Row Outer Seatbelt Pre-Tensioner

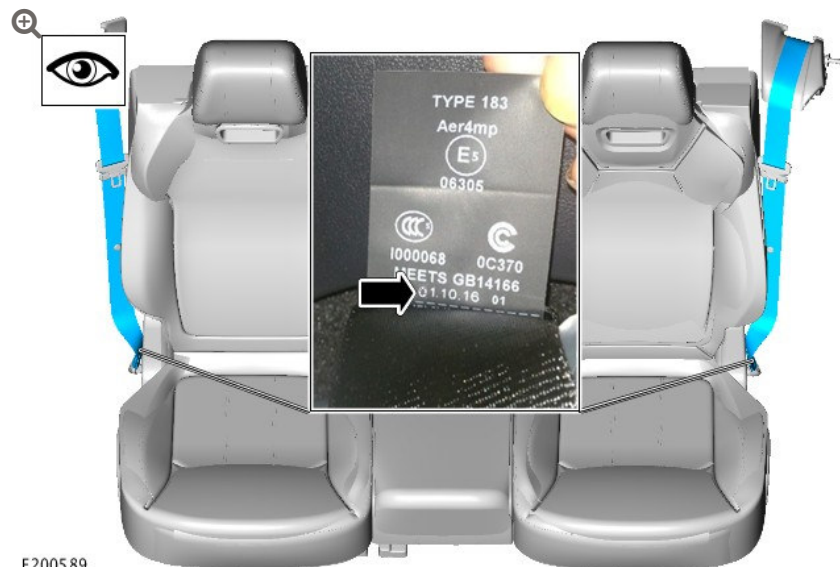
E200589

Visually check the date codes of the second row seating outer seatbelt labels.

- 29.09.16
- 01.10.16
- 03.10.16
- 04.10.16

- **10.10.16**
- If both second row seating outer seatbelt labels do not have one of the listed date codes, release the vehicle.
 - No further action required.
- If either second row seating outer seatbelt label has any of listed date codes, go to Step 2.

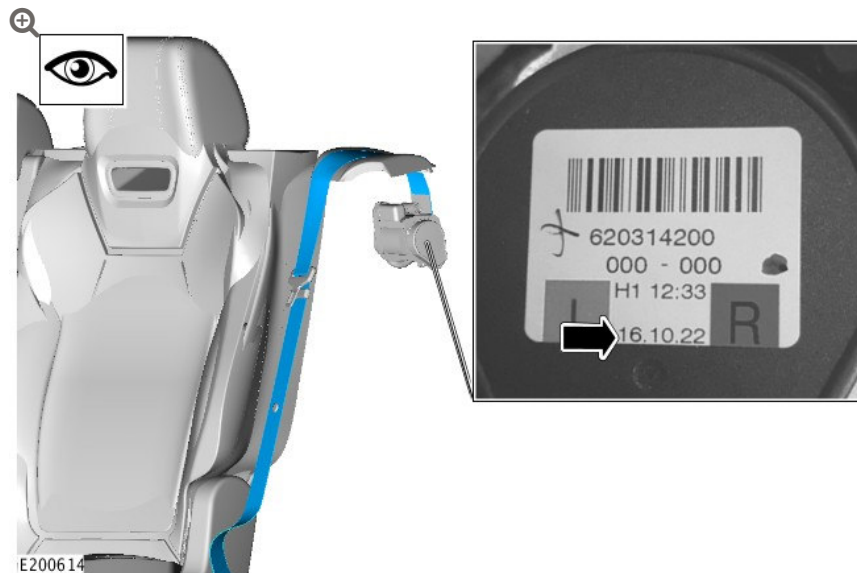
Visually check the second row seating outer left seatbelt retractor label date.

- **16.09.19**
- **16.09.20**
- If the label has one of the listed dates, **HOLD** the vehicle.
- If the label does not have one of the listed dates **AND** the second row seating outer right seatbelt

label passed the inspection (Step 1), reverse steps 2-8 to install the second row seating outer left seatbelt retractor using a new retractor bolt (LR084136).

- Release the vehicle.
- Go to Step 9 only if the second row seating outer right seatbelt did not pass the inspection (Step 1).

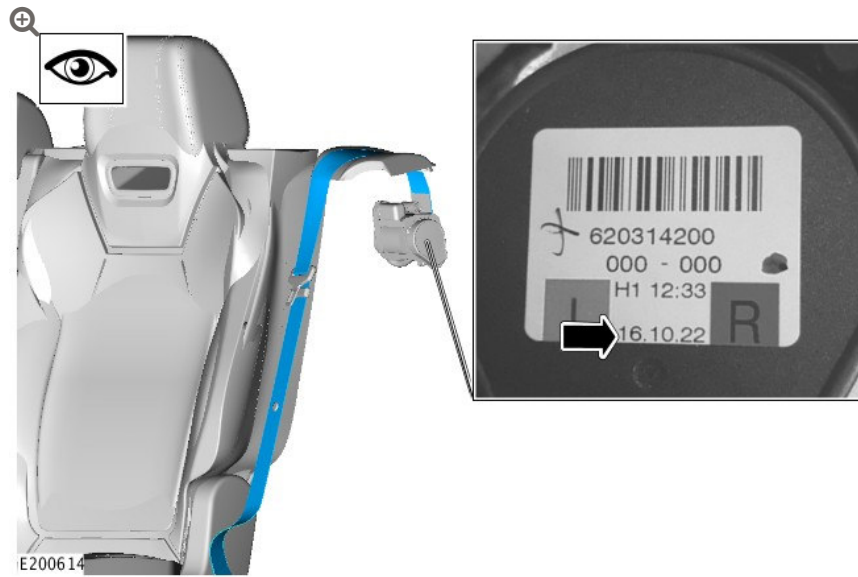
Visually check the second row seating outer right seatbelt retractor label date.

- **16.09.19**
- **16.09.20**
- If the label has one of the listed dates, **HOLD** the vehicle.
- If the label does not have one of the listed dates, reverse Steps 2 and 9-12 to install the second row seating outer right seatbelt retractor using a new retractor bolt (LR084136).
 - Release the vehicle.
