LTB01026NAS1

TECHNICAL BULLETIN

Rattle Noise Under Vehicle / Exhaust System Rear Heat Shield Cracked

MODEL:	MODEL YEAR:	VIN:	ASSEMBLY PLANT:
Range Rover Evoque (LV)	2012 Onwards	600000 Onwards	Halewood

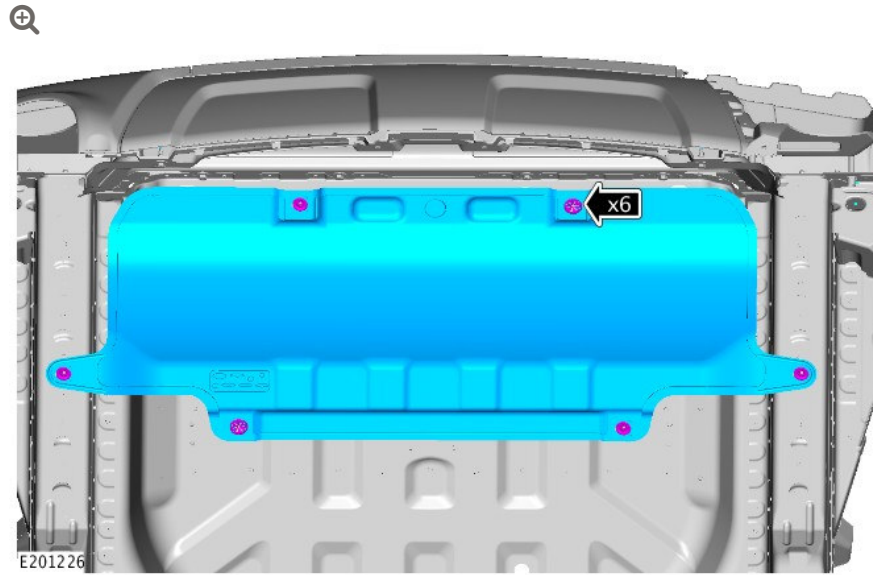
4

A rattle noise from underneath the rear of the vehicle may be evident. Upon further inspection the exhaust system rear heat shield is found to be cracked.

This may be caused by components which are manufactured outside of specification.

Both the heat shield and fasteners should be discarded.

Remove and discard the exhaust system rear heat shield and fasteners.
