Q664 UPS10216-2BNAS1

TECHNICAL BULLETIN

Update Prior to Sale: Incorrect Bracket Fitted To 3.0V6 Supercharged Petrol

MODEL:	MODEL YEAR:	VIN:	ASSEMBLY PLANT:	APPLICABILITY:
Range Rover Sport (LW)	2017	667482-671021	Solihull	V6 S/C 3.0L Petrol

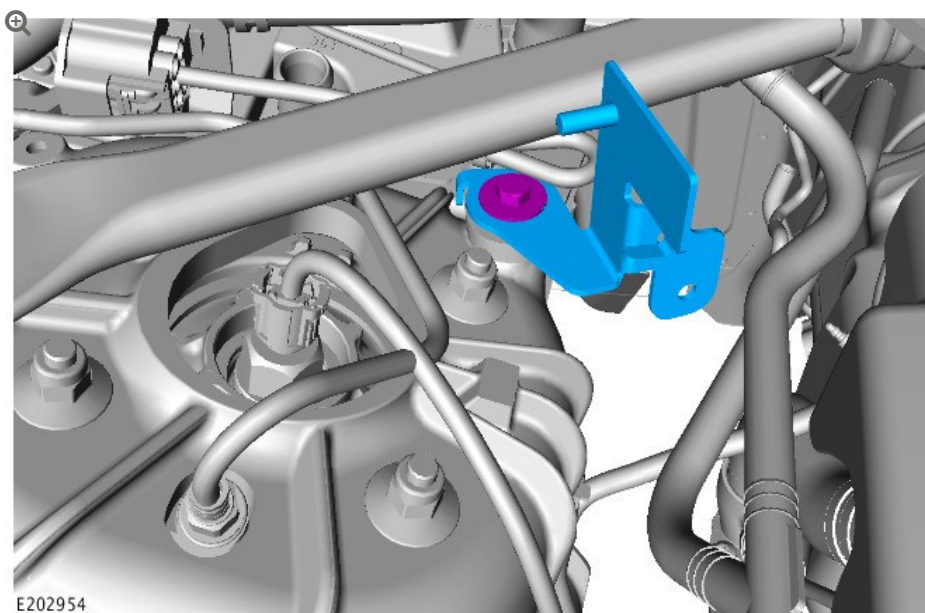
An issue has been identified on certain vehicles within the listed Affected Vehicle Range where a bracket has been fitted to the engine in error. The bracket can come into contact with an underhood coolant hose which over time could chafe and ultimately wear through, leading to loss of coolant.

2 **NOTE:**

Retain the bolt.

Remove and discard the unused bracket near the front right suspension top mount.
