Q648NAS1

# TECHNICAL BULLETIN

501-18

Update Prior to Sale: Convertible Roof Fraying

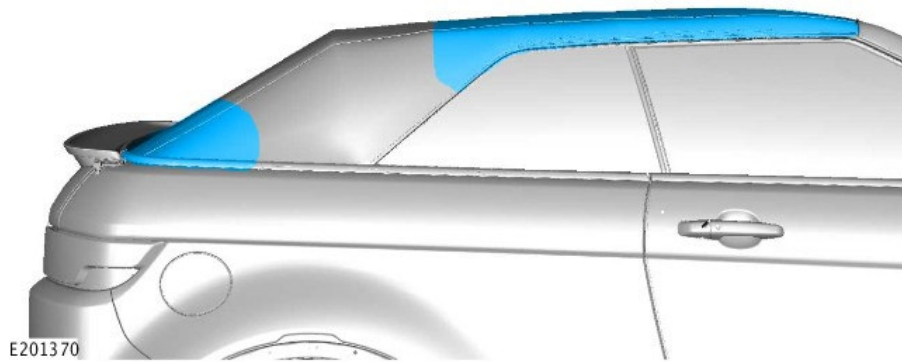
1

With the folding top fully closed, visually inspect the folding top in the areas shown for wear to the fabric or fraying of the fabric.

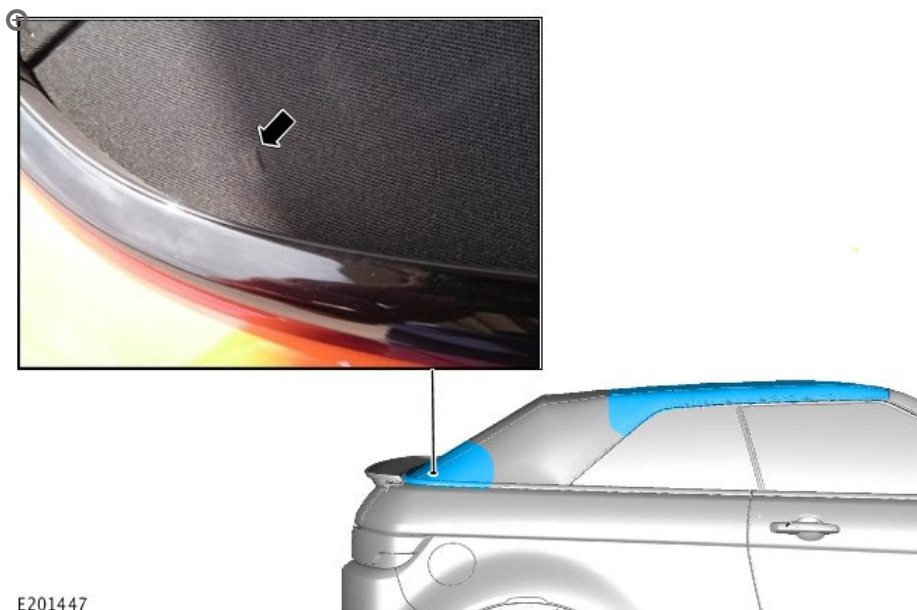
E201447

If there is wear to the folding top cover rear quarter area with damage to the fabric threads, go to Step 5 to replace the folding top cover.

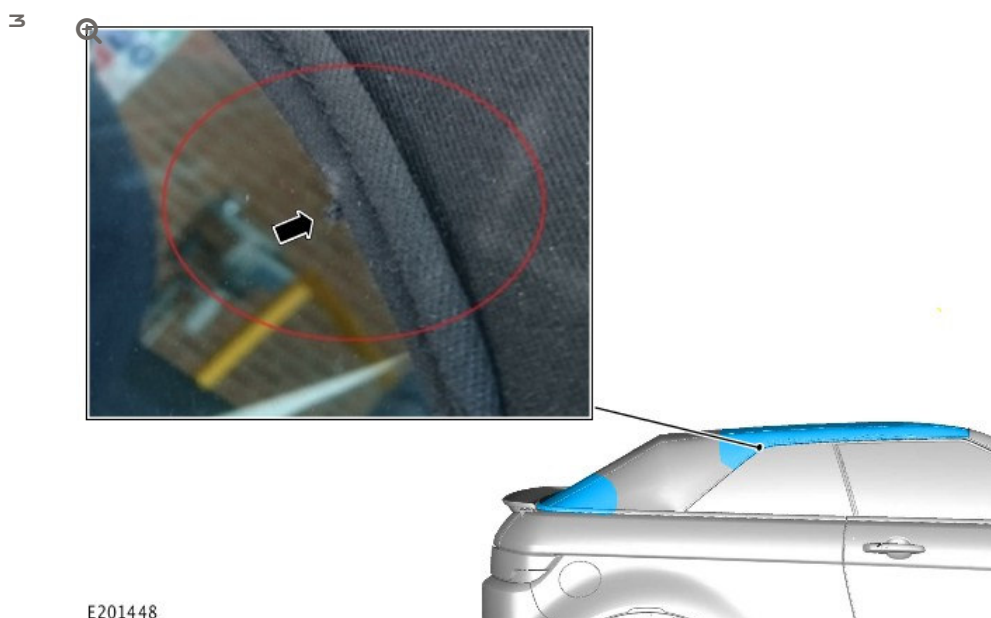
E201448

If there is wear to the folding top cover seam above the side windows with damage to the fabric threads, go to Step 5 to replace the folding top cover.

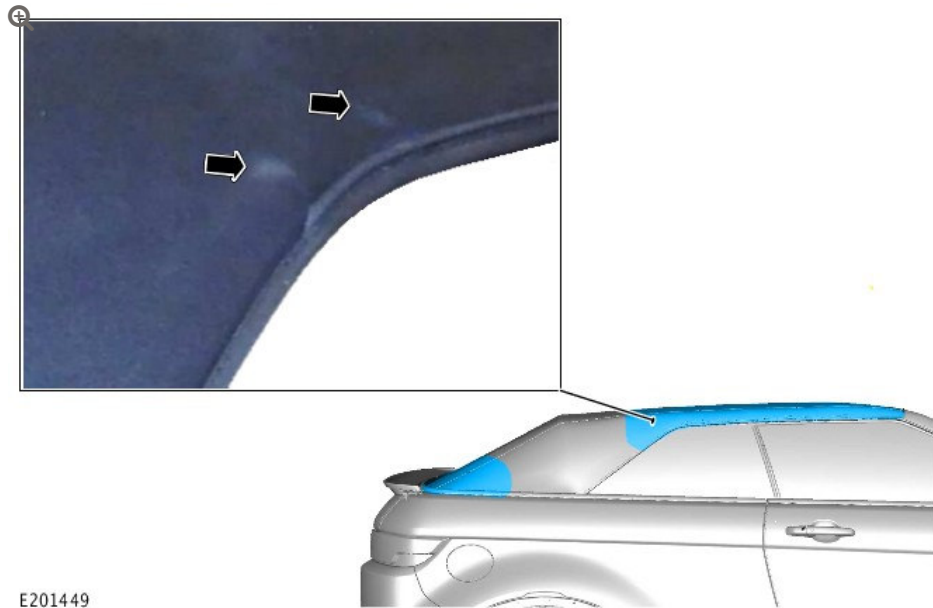
If there is no damage or only shiny patches on the folding top cover with no damage to the fabric threads, do not replace the folding top cover.

- 
- 5 Replace the folding top cover (see TOPIx Workshop Manual section 501-18: Folding Top - Folding Top - Folding Top Cover).
    - Following installation of the new folding top cover, proceed to step 6.
-
