LTB01002NAS1

# TECHNICAL BULLETIN

## A-Pillar Moulding Rubber Seal Adrift

| MODEL: | MODEL YEAR: | VIN: | ASSEMBLY PLANT: |
|---|---|---|---|
| Range Rover Evoque (LV) | 2012-2017 | 600001-203731 | Halewood |

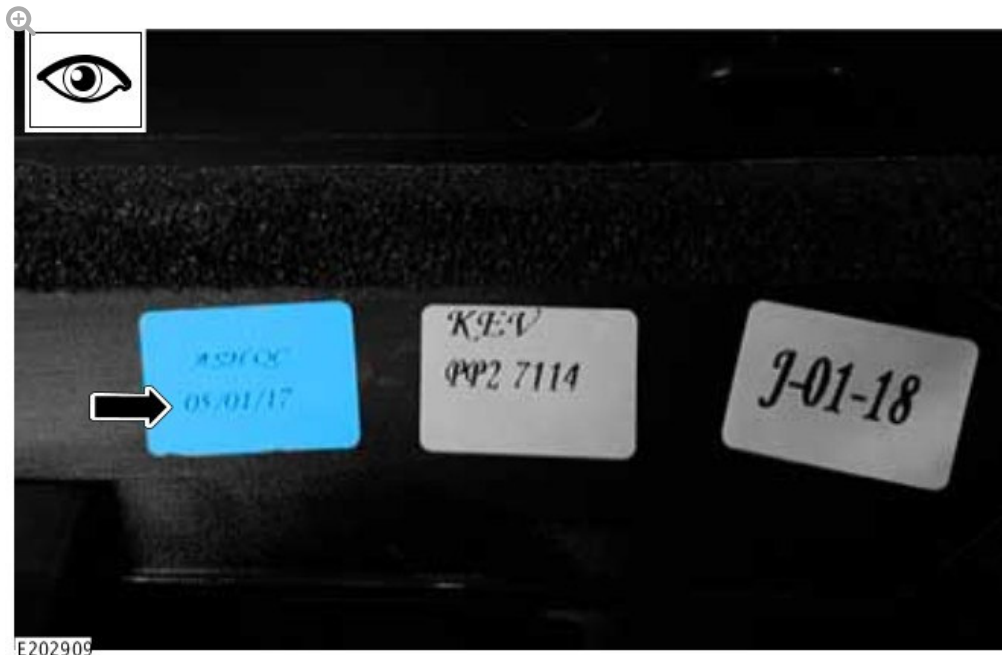
2

Visually inspect the date printed on the label attached to the new A-Pillar moulding.

- If the printed date is **25/11/16** or later, the part can be installed. Go to step 3.
- If the printed date is **24/11/16** or earlier, the part must not be installed.
  - Source a new A-Pillar moulding with a printed date of 25/11/16 or later.
  - Go to Step 3.
