# TECHNICAL BULLETIN

## Squeak/Rubbing Noise From Front Right of Vehicle While Driving

MODEL:	MODEL YEAR:	VIN:	ASSEMBLY PLANT:
Discovery Sport (LC)	2017 Onwards	606801 Onwards	Halewood
Range Rover Evoque (LV)	2017 Onwards	136146 Onwards	Halewood

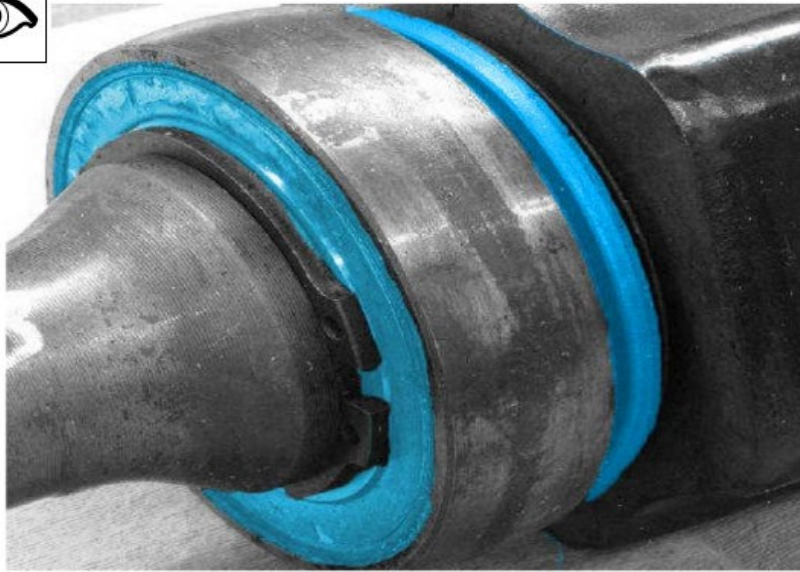
E202296

Visually inspect the halfshaft bearing outer seals to check they are not out of position or damaged.

- If either seal is damaged or out of position, go to Step 7.
- If both seals are not damaged and are in the correct position, continue to Step 6.

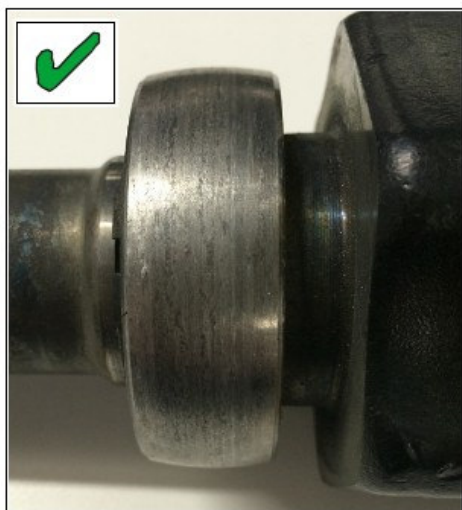
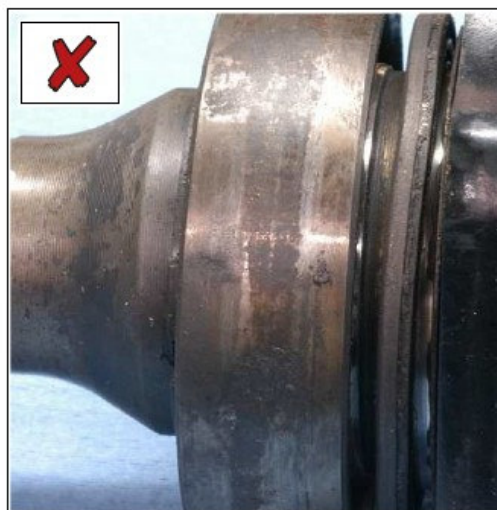
E202643

**Light scoring to the outer race of the bearing is acceptable.**

Visually inspect the condition of the halfshaft bearing and bearing housing.

- If bearing rotation is not harsh or noisy and the bearing is not badly scored (✓), go to Step 8.
- If bearing rotation is harsh or noisy and/or the bearing is badly scored (X), go to Step 7.

**The halfshaft and bearing should not be replaced unless bearing rotation is harsh and/or noisy or if outer bearing seals are damaged or displaced.**

Replace the front right halfshaft (see TOPIx Workshop Manual section 205-04: Front Drive Halfshafts - Front Halfshaft RH).
