N006 UPS0417-3BNAS1

# TECHNICAL BULLETIN

Update Prior to Sale: Incorrect VIN Certification Label

MODEL:	MODEL YEAR:	VIN:	ASSEMBLY PLANT:	APPLICABILITY:
Range Rover Sport (LW)	2017	124092-134855	Solihull	V8 S/C 5.0L Petrol, Vehicles With: SVR

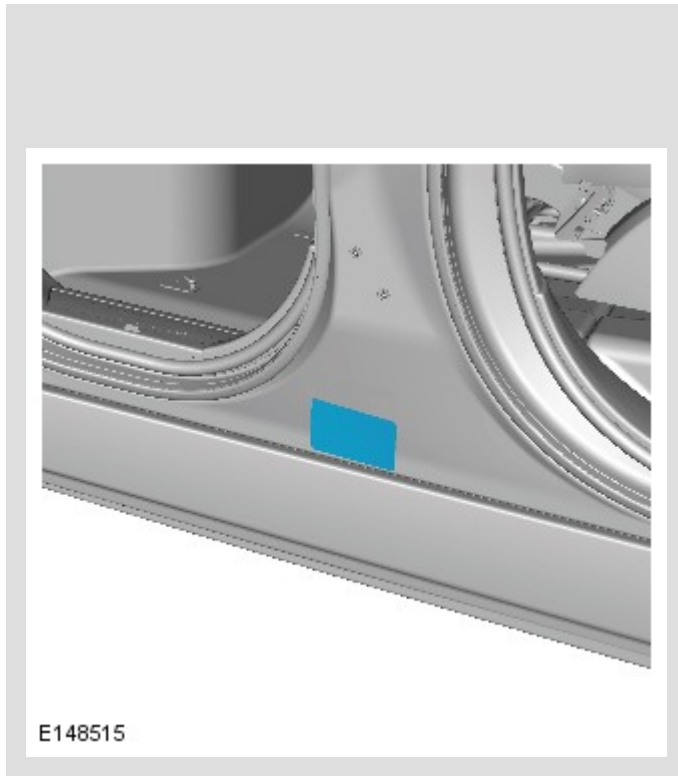
2

An issue has been identified on certain vehicles within the listed Affected Vehicle Range where the incorrect VIN Certification Label has been fitted.

Remove the existing VIN Certification Label attached to the left B-Pillar.

All traces of existing label must be removed.

Use a suitable spirit wipe as necessary.
