N008NAS1

TECHNICAL BULLETIN

Service Action: Sport Badge Not Fitted

MODEL:	MODEL YEAR:	VIN:	ASSEMBLY PLANT:
Range Rover Sport (LW)	2017	666892-671630	Solihull
Range Rover Sport (LW)	2017	124082-135805	Solihull

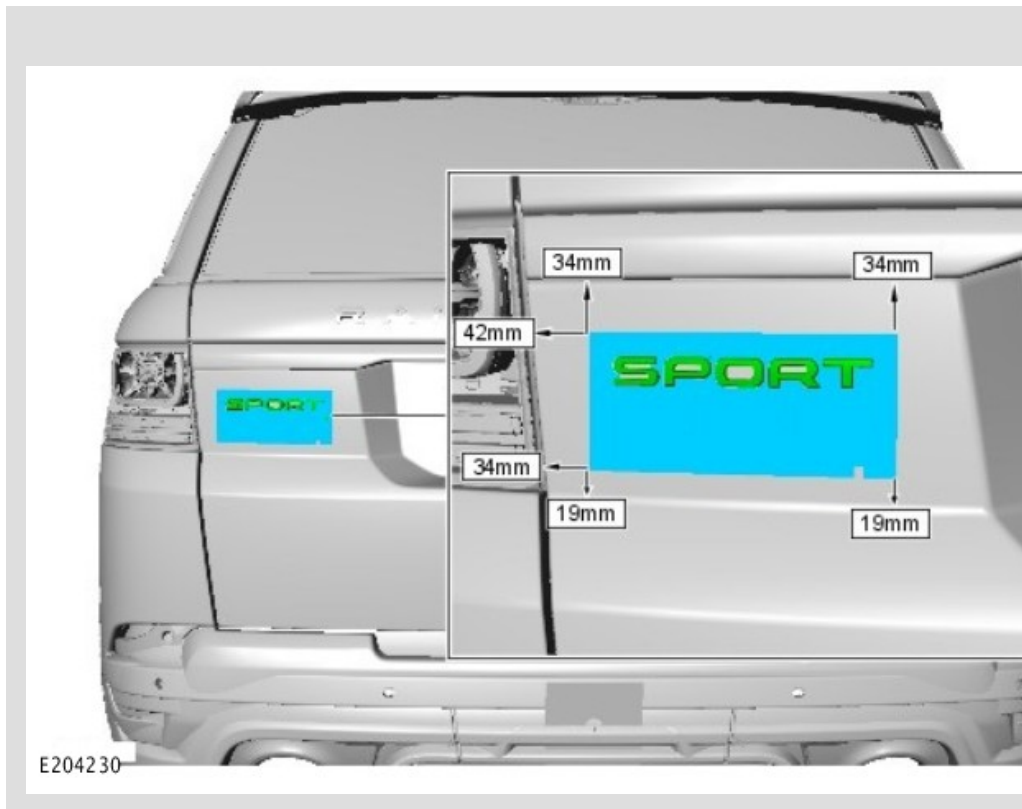
- 2

An issue has been identified on certain vehicles within the listed Affected Vehicle Range have been manufactured away from process where the 'SPORT' badge is not fitted to the tailgate.

- The new tailgate SPORT badge is supplied on a cassette (highlighted in blue).
- All dimensions shown are to the edge of the new badge cassette.

Install the tailgate SPORT badge in the position shown.
