SIL 3-EP-17  
February, 2017  
Page 1 of 28

**SUBJECT:** Replacing Gate Drive Cards Inside the Dual Power Inverter Module 2 (DPIM2)

**MODELS AFFECTED:** H 40/50 EP™ System Equipped With DPIM2

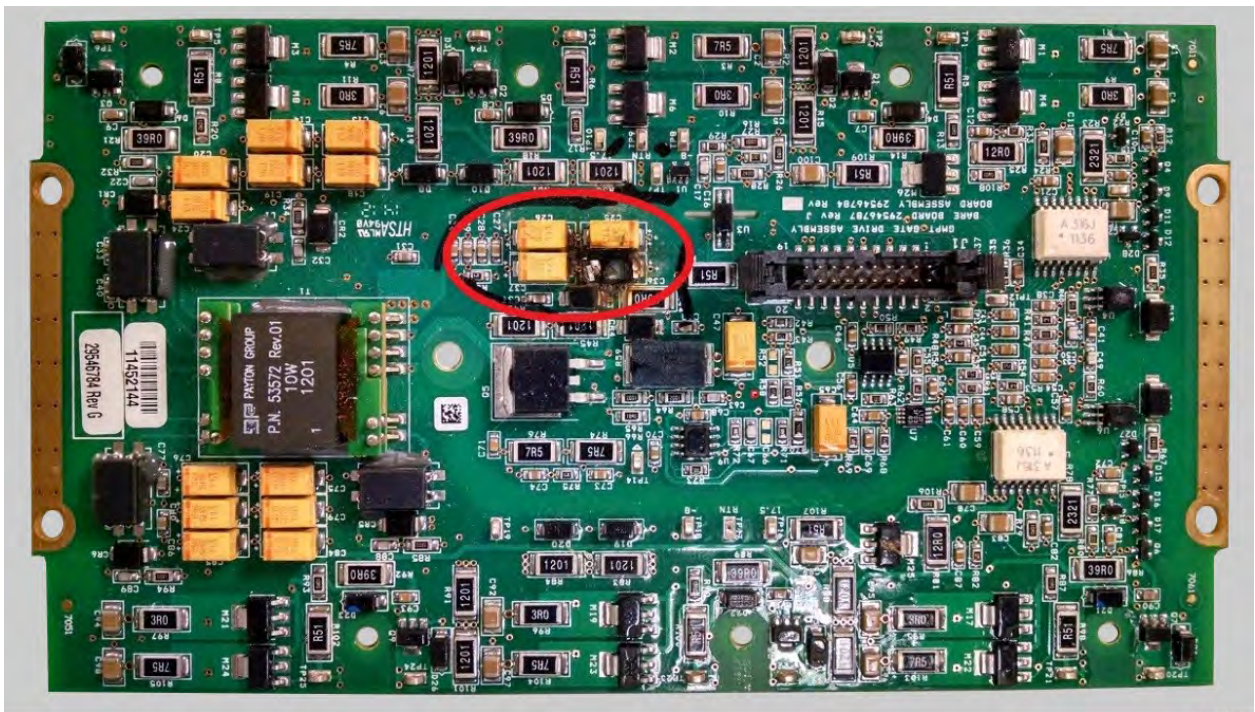
A Gate Drive Card may become damaged in various ways but typically it is due to a board-level component failing, either visually or internally. Visual examples include any of the tantalum capacitors (refer to [Figure 1](#)) or resistors burning. Board-level components can fail internally without any physical signs of damage.

DTCs that can set due to a failed Gate Drive Card include 73-58 and 74-58. At this time, unless there is visual damage to the card, there is no way to determine which of the three (3) Gate Drive Cards have failed. If there is no visual indication of which card has failed, all three (3) Gate Drive Cards will need to be replaced.

**Figure 1. Burnt Tantalum Capacitor on Gate Drive Card**

This Service Information Letter (SIL) announces the availability of the Gate Drive Card (P/N 29546784) and includes the procedure to replace the Gate Drive Cards located inside the DPIM2. The availability of these parts eliminates the need for a complete DPIM2 replacement under certain failure conditions.

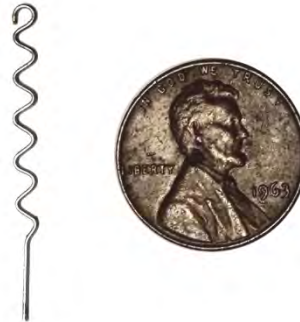
**CAUTION:** The spring pins (refer to Figure 2) located in the SKiM<sup>®</sup> module that contact the bottom of the Gate Drive Card are NOT available for replacement if lost or damaged. Extreme caution must be used during removal of any Gate Drive Cards to ensure no spring pins are damaged or lost.

**Figure 2. SKiM<sup>®</sup> Module Spring Pin**

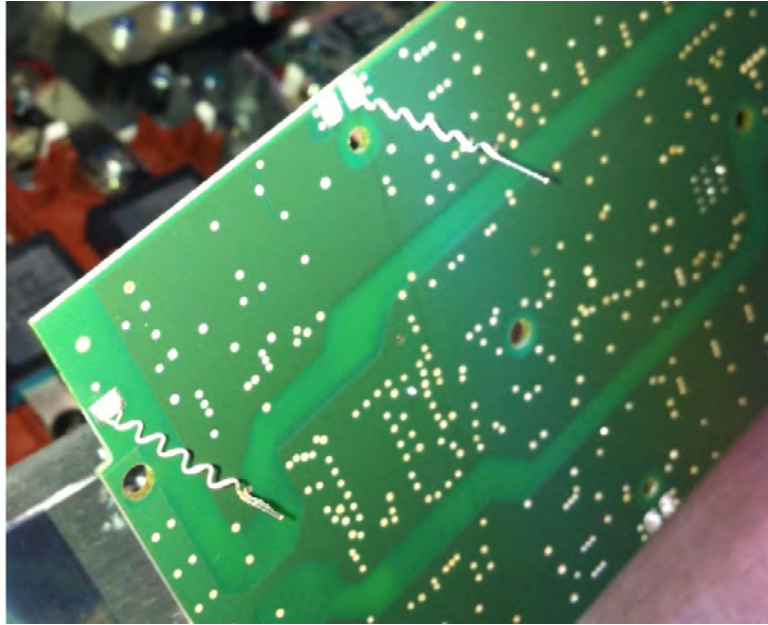
**Figure 26. Spring Pins Stuck to Gate Drive Card Solder Pads**

5. If any spring pins are stuck to the bottom of the card (refer to [Figure 26](#)), remove them from the solder pad taking care not to bend or lose the pin. Reinstall the spring pin into the corresponding hole in the SKiM® module (refer to [Figure 25](#)).
