TT8025EN  
August, 2017  
Page 1 of 14

**SUBJECT:** Incorrect 5th Generation Controls Engine Brake Calibration Setting In Certain Freightliner Custom Chassis Corporation (FCCC) Motorhomes May Cause Transmission To Not Downshift During Engine Braking Event

**MODELS AFFECTED:** 2500MH Transmissions in FCCC Motorhomes with Allison 5th Generation Controls

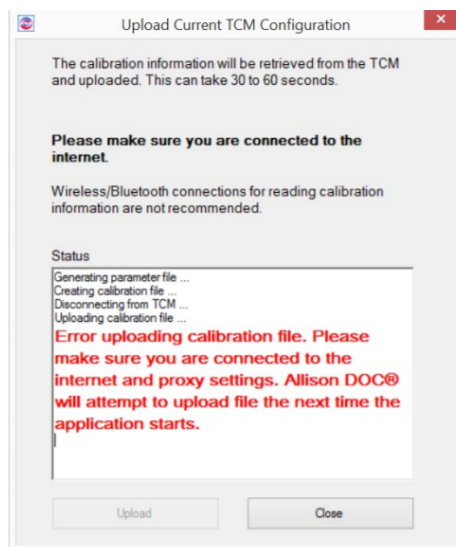
**Figure 6. TCM Configuration – Error Message**

**NOTE:** If you are not connected to the internet, the error message displayed in [Figure 6](#) will appear. Allison DOC® will retrieve the file and attempt to upload the file the next time the application starts with internet access.
