Number: FS-2017-05

Model: All Buses

Model Years: 2013 - 2017

**Subject: Removing "Duck Bill" Valves In Rear Run Box**

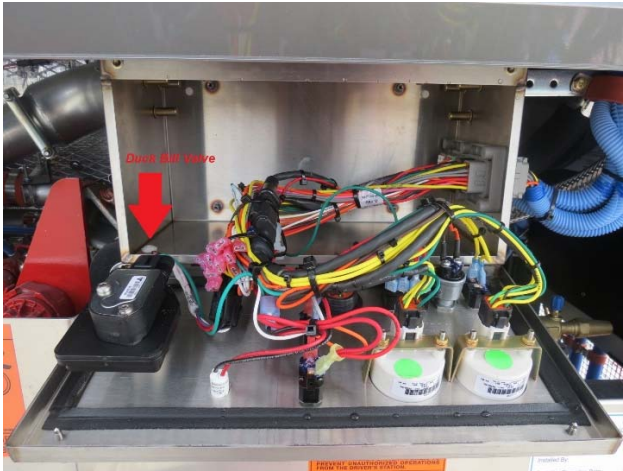
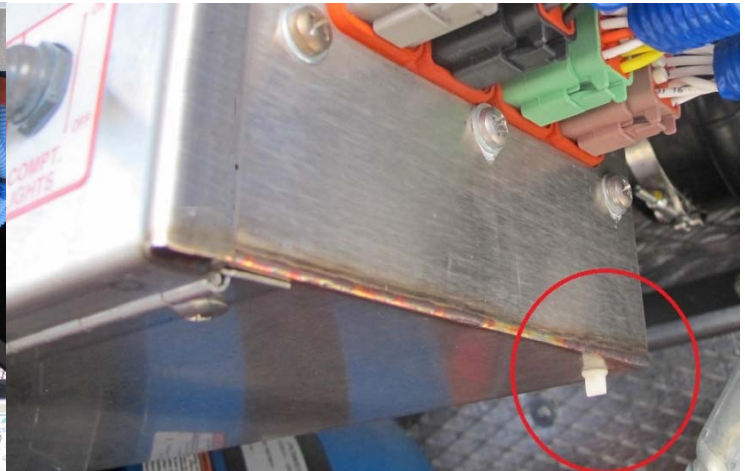
***We have found that the 'duck bill' valves in the bottom of the rear run box can keep water trapped inside the box.***

***This water remaining inside the rear run box can keep moisture trapped, and contribute to corrosion of some components.***

***We ask that you remove the duck bill valves to allow all the water to drain out.***
