HYUNDAI

Technical Service Bulletin

GROUP CAMPAIGN	NUMBER 17-01-055
DATE AUGUST, 2017	MODEL(S) SONATA 2.4L (LFa)

SUBJECT 2.4L OIL COOLER HOSE CLAMP INSPECTION
(SERVICE CAMPAIGN T2H)

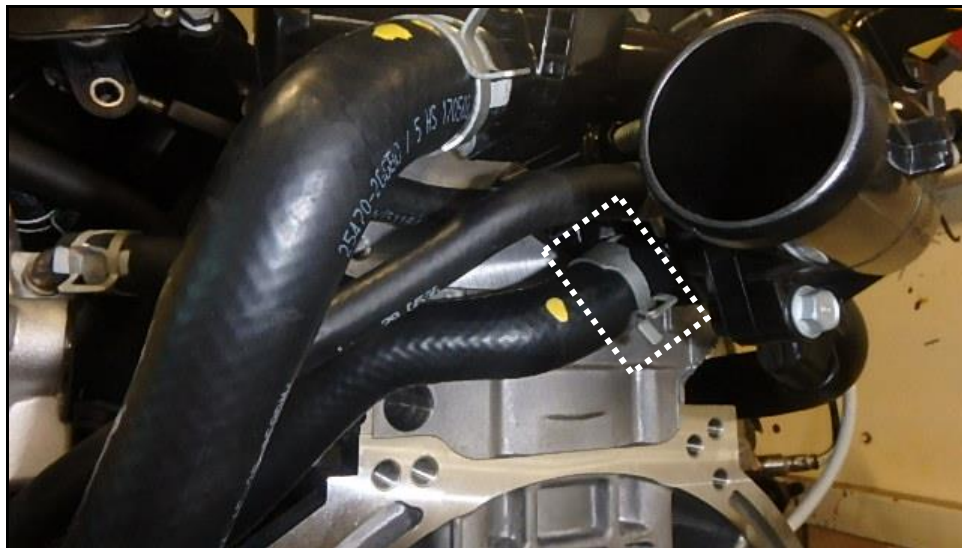
Description: Some 2017MY Sonata 2.4L (LFa) vehicles may have an improperly positioned oil cooler hose clamp. This may result in a coolant leak. Follow the procedure outlined in this bulletin to inspect and reposition the oil cooler hose clamp.

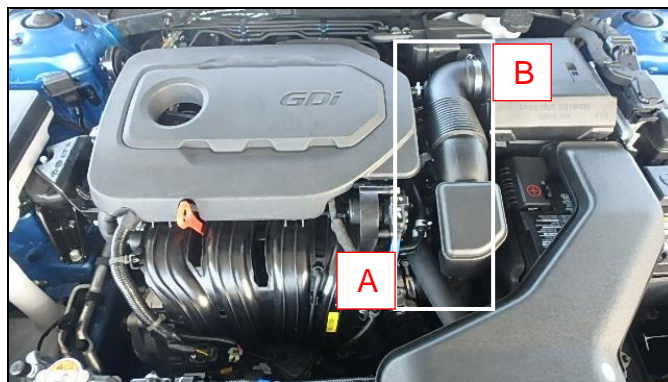
1. Loosen the two hose clamps (A at the throttle body and B at the air cleaner) of the air intake hose and move the air intake hose to the side.
2. Inspect the hose clamp position of the lower oil cooler hose at the Water Temperature Control (WTC) housing.
 - The correct position of the clamp should be approximately 3/8" from the WTC housing as shown in the dotted boxed area (C).

The lower oil cooler hose and clamp is located at the bottom of the WTC housing (just below and behind the throttle body heater hose).

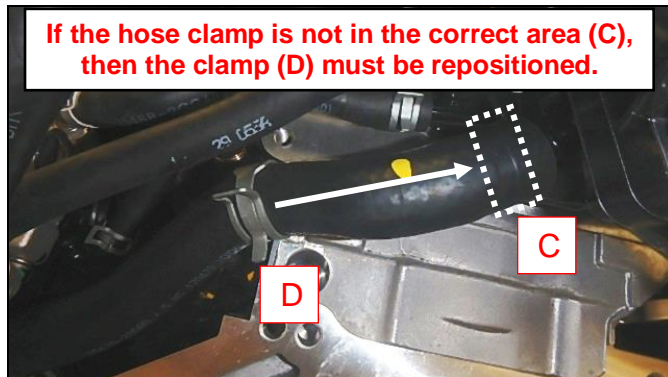
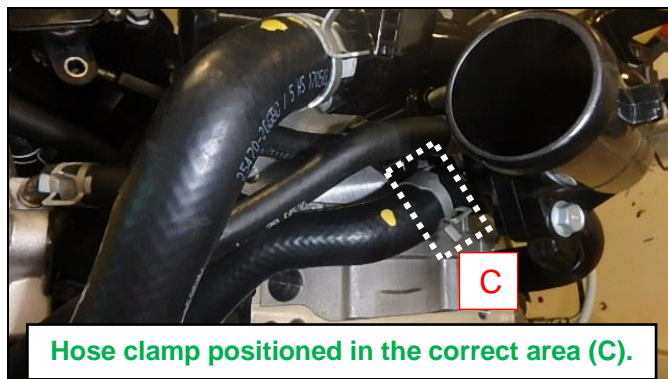
If the hose clamp is not in the correct area (C), then the clamp (D) must be repositioned.

If the hose clamp is not in the correct position such as the clamp (D) in the example picture, then reposition the hose clamp within the correct the location as shown (C).
