<b>HYUNDAI</b> <b>Technical Service Bulletin</b>	<b>GROUP</b> <b>AUTOMATIC TRANSMISSION</b>	<b>NUMBER</b> <b>17-AT-005</b>
	<b>DATE</b> <b>AUGUST, 2017</b>	<b>MODEL</b> Accent (RB), Azera (TG/HG), Elantra (UD/MD/GD/JK/AD/ADa/PD), Santa Fe (CM/AN/NC), Sonata (LF/YF/YF HEV/LF HEV), Tucson (LM/TL) Veloster (FS)
<b>SUBJECT:</b>	<b>AUTOMATIC TRANSAXLE DIAGNOSIS (6-SPEED)  INHIBITOR SWITCH DTC P0705, P0706, P0707 &amp; P0708</b>

***This TSB supersedes TSB 15-AT-001 to update the Service Procedure and applicable vehicles.***

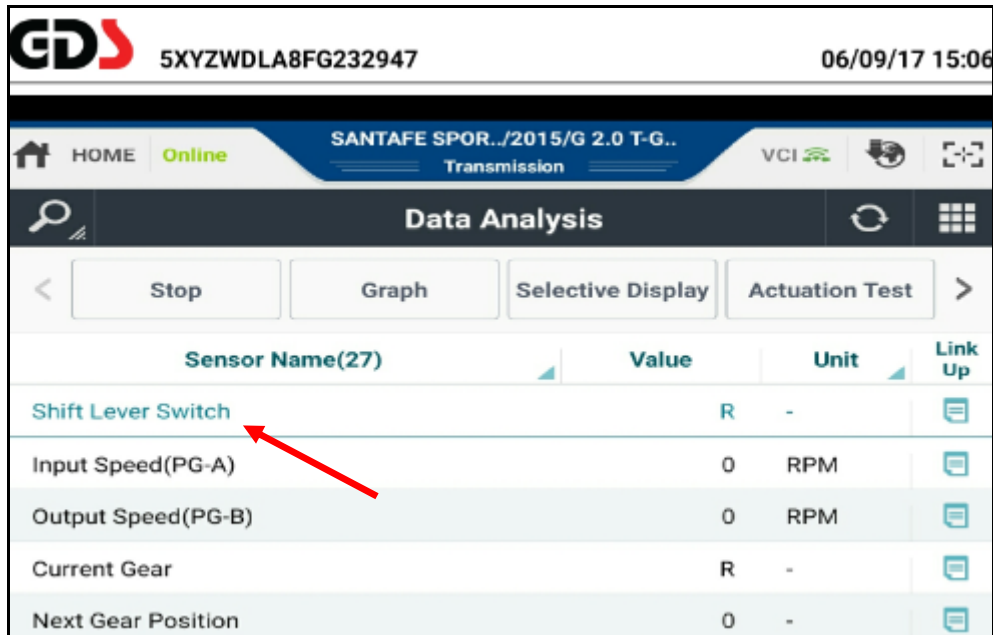
3. Select **Data Analysis**, **A/T** menu and **Shift Lever Switch**. Move the shift lever through all gears (P, R, N and D) and monitor the Shift Lever Switch.

4. If the Shift Lever Switch shows:
  - The correct shift lever position, the wiring **currently** has no open/short circuits. Go to Step 6.
  - Does not show the correct shift lever position, go to Step 5.
5. Visually check the wiring harness between the PCM and inhibitor switch for a damaged wire or open circuit/short circuit to ground. Check for a damaged pin or pin not fully inserted into the connector.
  - If damage is found, repair or replace the control wiring and drive the vehicle to confirm the repair.
  - If no damage or open/short circuit is found, go to Step 6.

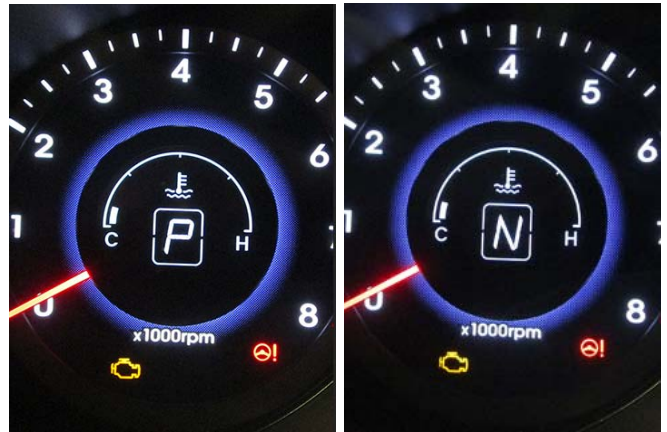
6. Turn the ignition switch to the ON position and place the shift lever in P and N. Confirm the indicator lights in the dash cluster show the correct gear in P and N.
  - If P and N are displayed, go to Step 7.
  - If P or N are not displayed, go to Steps 9~12 and 15 and check the alignment of the inhibitor switch. If P and N are not displayed after adjustment, go to Step 7.

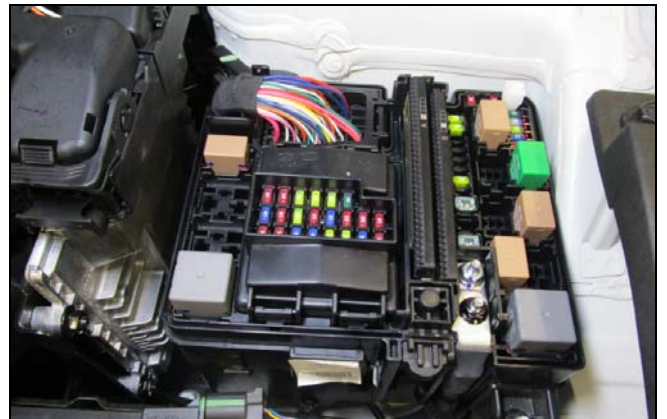
7. Check the TCU and TCU2 fuse in the junction box in the engine compartment:
  - Check the fuse for an open circuit.
  - Check the fuse for correct capacity.
  - Check the fuse holder for a tight fit.
  - Check for loose or damaged wires.

If damage or intermittent open circuit is found, repair or replace the junction box and front harness.

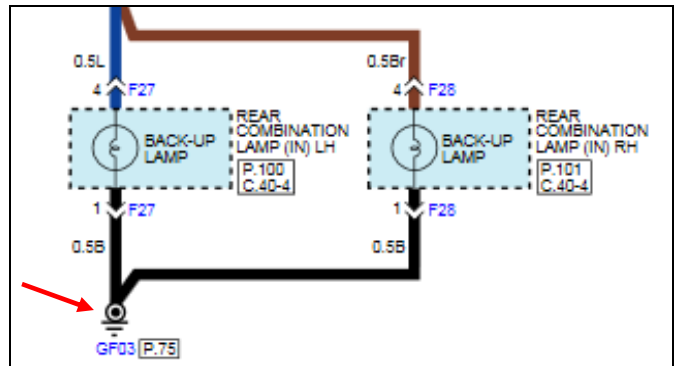
8. Check the rear combination lamp ground for tightness.  
**Torque: 7~9 lb-ft (1.0~1.2kgf.m)**

Turn the ignition and headlights on. Use a DVOM to check the voltage drop between the combination lamp wiring terminal and ground. Specification: Less than 0.2 V.

If more than 0.2V, clean the terminal and bolt threads and tighten the bolt.  
 If less than 0.2V, go to Step 9.
