EC16-035a ITB17-042a August 21, 2017

INFINITI; DTC P0456 CAUSED BY EVAP LEAK AT VENT CONTROL VALVE O-RING

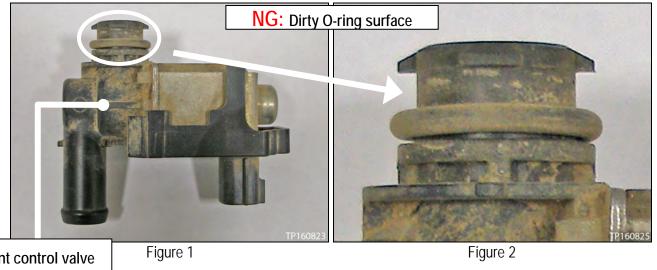
Vent control valve

- DTC P0456 is not caused by a loose fuel fill cap (refer to ITB13-044).
- An EVAP leak has been detected where the vent control valve mounts to the canister.
- The vent control valve O-ring seal is determined to be the cause.

- 1. Replace the O-ring.
 - To access the O-ring, refer to the appropriate section in the Electronic Service Manual (ESM) of the APPLIED VEHICLE for vent control valve removal and installation.
 - This O-ring is now available separately (see PARTS INFORMATION).
 - When installing, do not add any lubrication to the O-ring.
 - Seat the O-ring all the way down as shown on page 4, Figure 7.
 - ➤ Having the O-ring seated all the way down will assure it is not twisted or rolled over.
 - Refer to the pictures on pages 3 and 4 for additional installation information.

- Make sure the surfaces that the O-ring comes in contact with are clean.
- ➤ When installed, make sure the O-ring is not twisted or rolled over.
- Verify the repair is complete by checking for leaks with a "smoke" leak detection machine or CONSULT-III plus (C-III plus).
 - If a "smoke" leak detection machine is used, follow the manufacturer's operating instructions.
 - ➤ If C-III plus is used:
 - 1. Confirm the fuel filler cap is secure.
 - 2. Connect Essential Tool J-42909 to the EVAP service port.
 - 3. Using Active Test, close the vent control valve.
 - 4. Apply pressure using J-42909 until the bar graph reaches about halfway.
 - 5. Monitor the bar graph for 10 minutes.
