SERVICE BULLETIN

APPLICABILITY: 2013-2017MY Impreza
 2013-2017MY Crosstrek
 2012-2017MY Forester, NA and Turbo
 2015-2017MY WRX
 2013-2017MY BRZ

NUMBER: 02-166-17R

SUBJECT: Upper Oil Pan Assembly- Design Changes

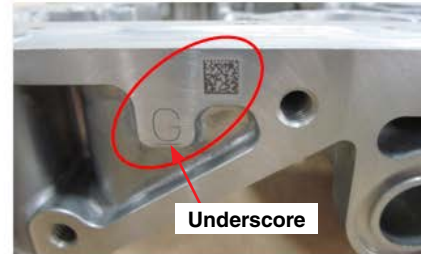
- An underscore has been added to the identification letter found on the front face next to the water pump cavity and QR code box.

IMPORTANT NOTE: If the identification letter is a “N”, the casting is a p.n. 11120AA250 which is NOT affected by this TSB.

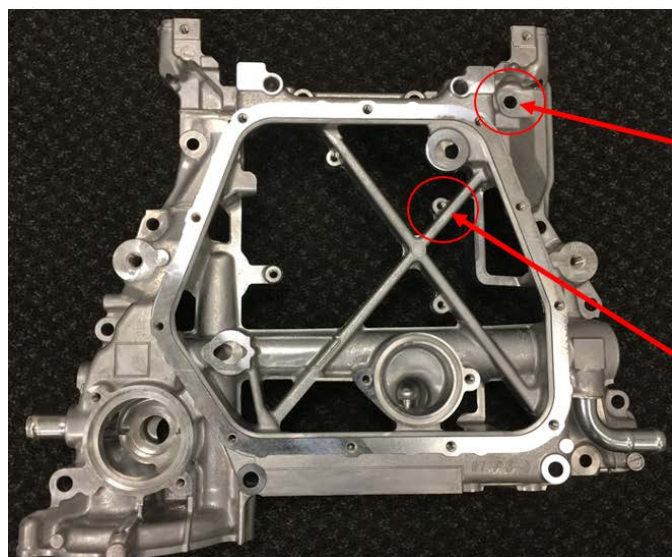
- The mating flange thickness of the casting in the area identified as the cause for the seepage has been increased by 5.5mm. (See images provided in the Parts Information section below.) This thickness increase creates the need for a longer bolt to provide proper tightening and retention.
- An additional mounting point has been added to the ribbing inside the casting to increase retention of the steel baffle plate and eliminate vibration.

- Thicker casting and an additional mounting point for the baffle plate added to the internal ribbing.

Because the thickness of the casting has been increased by 5.5mm in this area, a new, longer socket-head cap screw, p.n. 800408250 is required replacing the original hex head bolt.

An additional mounting point / bolt hole has been incorporated here to improve retention of the baffle plate. Use hex bolt p.n. 808206010.
