SERVICE BULLETIN

APPLICABILITY: 2017MY Impreza

NUMBER: 15-211-17R

SUBJECT: Reprogramming File Availability Offering
Additional Optimization of Harman Gen 3 Audio
and Navigation Head Units

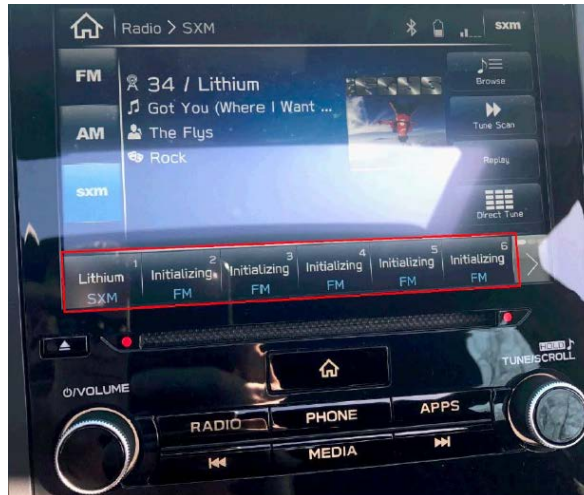
- 1- Radio station presets disappear (touch screen buttons return to “Initializing”).

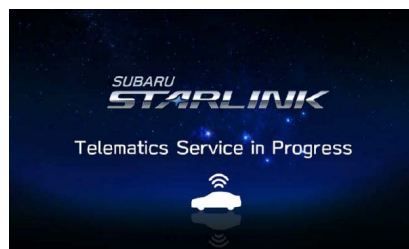
- 2- STARLINK “Telematics Service in Progress” screen freezes.

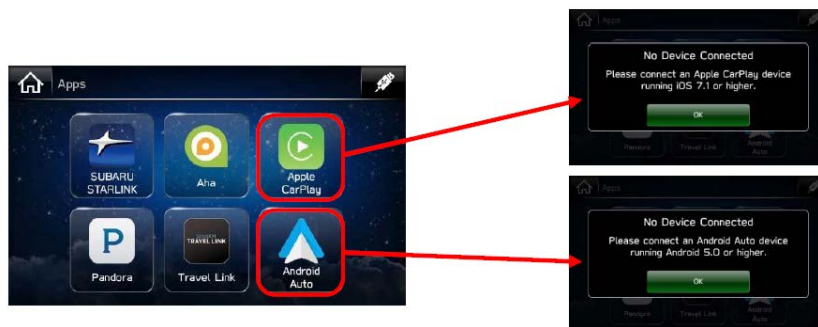
- 3- Apple Car Play / Android Auto function does not operate (“No Device Connected”).

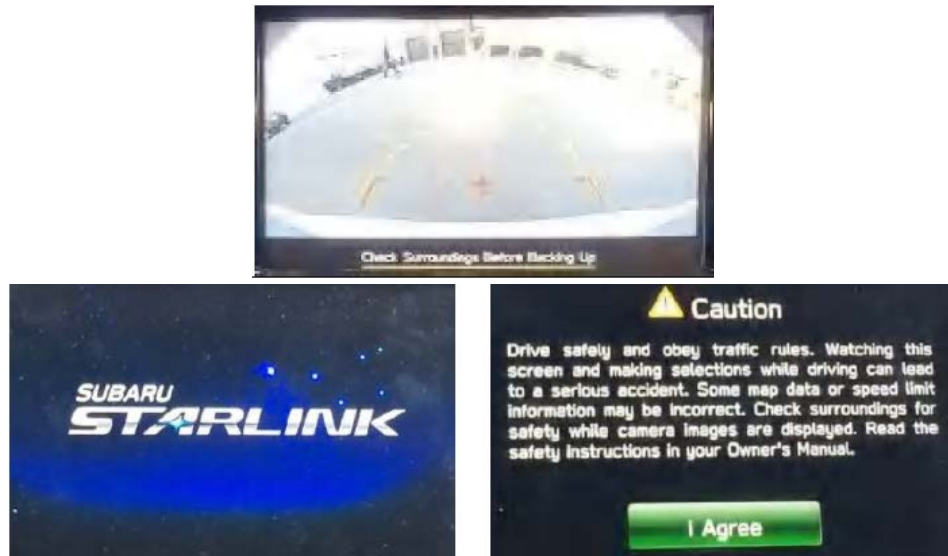
For reference, the previously released WTN-74 symptoms are also provided below. The main purpose of WTN-74 is to address display screen freeze-up during Back-Up Camera display (when the shifter is in “R”). In addition, the screen may also freeze when either the Subaru STARLINK or Disclaimer Caution / I Agree is displayed.

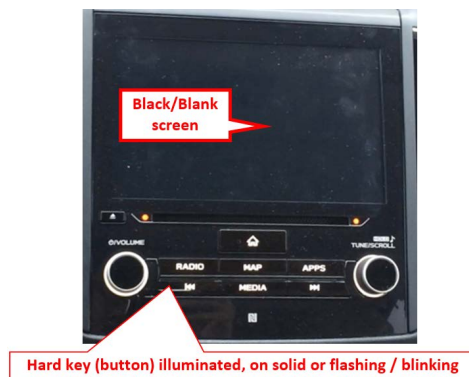
- 1) After switching the vehicle (ACC or IGN) on, the display screen goes black with no audio output and the hard key buttons are illuminated (on solid, or flashing / blinking).

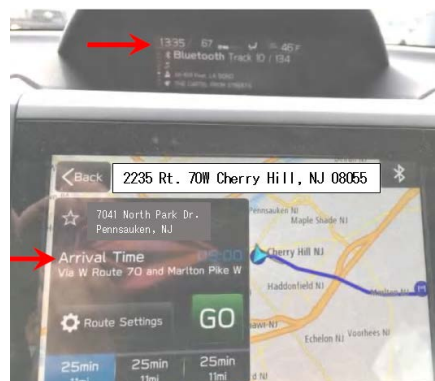
- 2) Time of day displayed in the MFD (Multi-Function Display) is incorrect and the arrival time displayed in Navigation units is also incorrect.

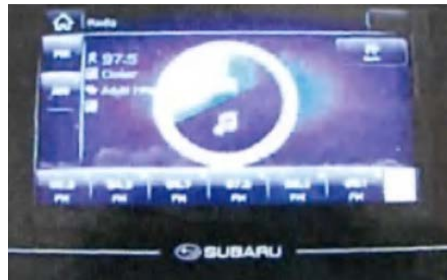
- 3) The time in the MFD automatically reverts to a “default” setting, even after setting the time using “Manual” mode.
- 4) Audio volume goes to maximum automatically after one click of the volume up button on the steering wheel. In some cases, this condition may also occur without input from the operator. Maximum volume is also displayed on the screen.
