SERVICE BULLETIN

APPLICABILITY: XV Crosstrek Hybrid (HEV)

NUMBER: 16-108-17

SUBJECT: New Service Procedure for Repair of DTC P172A and P0B0B

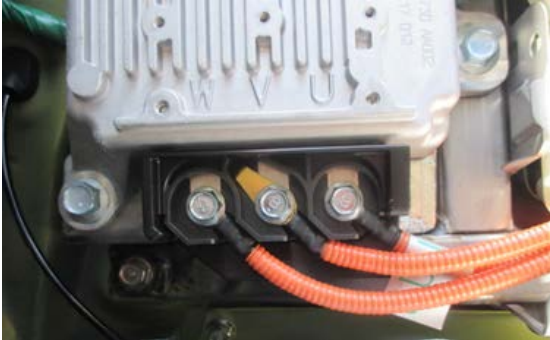
- Remove the TORX screws and necessary trim clips securing the aluminum battery cover.
- **ONE AT A TIME**, remove the 3 bolts securing the orange “W”, “V”, and “U” cables to the electric oil pump inverter. As each cable is removed, cover each terminal end with one of the strips of electrical tape to insulate it. Connect the RED (+) test lead from the DVOM to the “U” cable end and BLACK (-) lead to the “V” cable end as shown. Confirm the “W” cable end is wrapped with insulating tape.

- **IF THE DVOM SHOWS 0.5V OR MORE:** The relief valve o-rings are damaged. Replace the relief valve following the new procedure supplied below.
- **IF THE DVOM SHOWS LESS THAN 0.5V:** the root cause of the DTC is elsewhere. Continue diagnosing the DTC using the applicable Service Manual procedure.

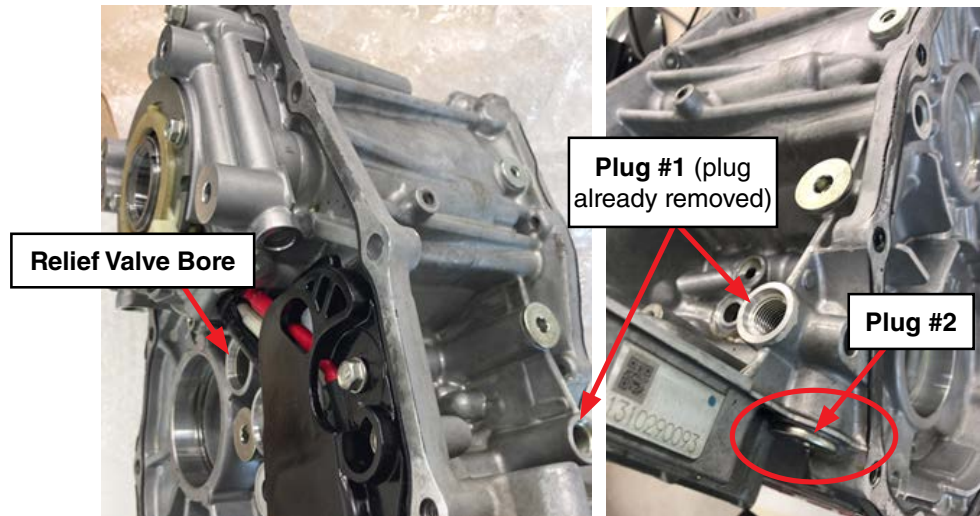
- Remove **Plug #1** and **Plug #2** as shown in the photos below and allow any remaining CVTF to drain.

- REMINDER:** Always wear eye protection for this step: Thoroughly clean the bores with spray parts cleaner then blow dry with compressed air. Always direct the spray away from other people and vehicles. Re-inspect closely for any remaining contamination.
- Install **new** o-rings on both plugs, lubricate with CVTF and re-install. Torque these 2 plugs to 50 Nm (37 ft. lbs.).
- Lubricate the o-rings with CVTF then **CAREFULLY** install the new relief valve assembly (cut-out portion in first) until it is fully seated in its bore. Use caution to avoid damaging the new o-rings on the plug threads. The valve can be installed in any rotational position.
