SERVICE BULLETIN

APPLICABILITY: 2015-16MY and Early 2017MY Legacy and Outback

NUMBER: 07-114-16R

SUBJECT: Power Seat Memory Feature Operating Concerns

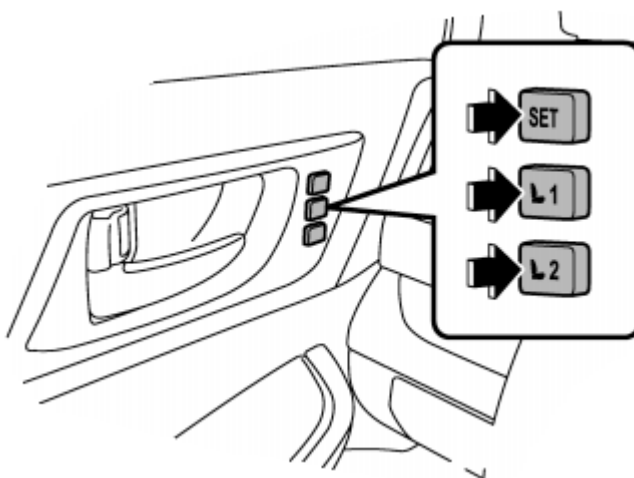
This bulletin announces availability of a new power seat memory control module designed to address customer concerns of the seat memory feature not operating properly. When pressing the buttons to recall one of the last seat positions memorized, the seat (height, backrest position, etc.) may not always return to the correct or exact positions previously selected (or stored in the control unit memory).

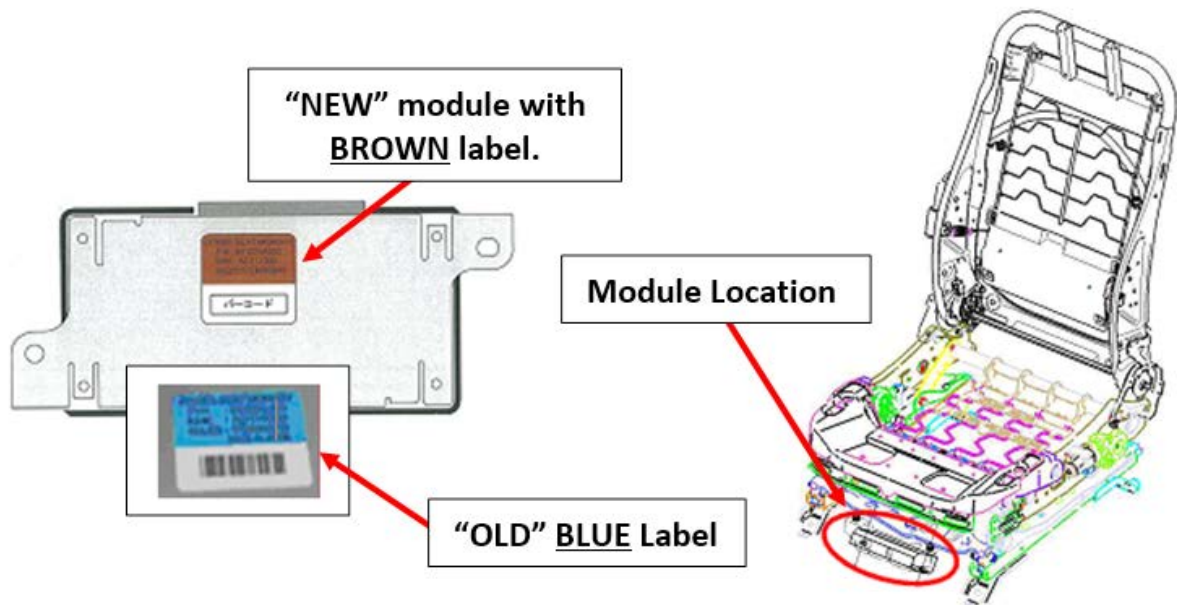
IMPORTANT: The part number and location of the new seat memory control module are unchanged. For this reason, the color of the part number label affixed to the module must be confirmed to differentiate between the old and new parts as shown in the illustration below. The old module label is Blue (inset) while the new version is Brown.
