SERVICE BULLETIN

APPLICABILITY: 2013-2015MY BRZ

NUMBER: 12-225-17

SUBJECT: Water Leak onto Passenger's Front Floor

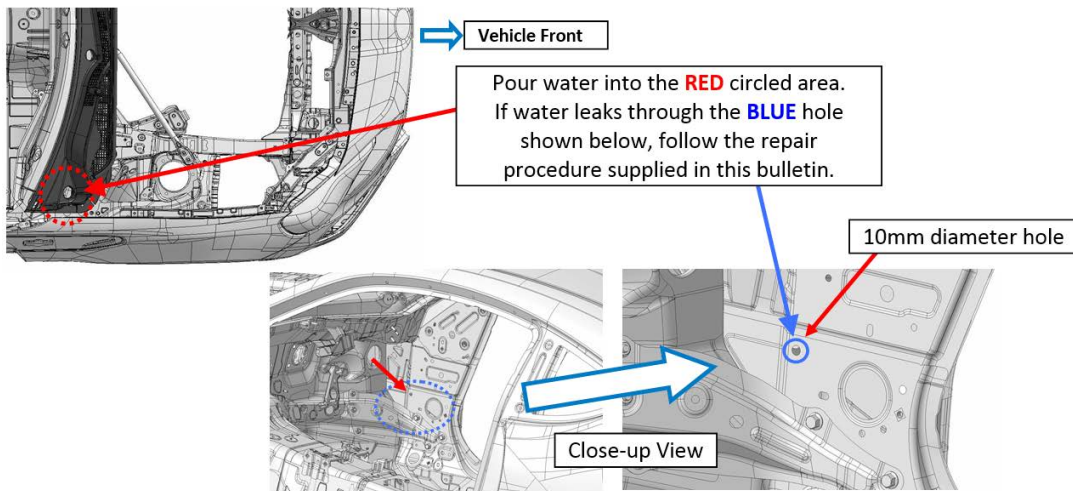
2. Record the Customer's radio station presets (and navigation favorites where applicable).
3. Disconnect the negative battery terminal.
4. Remove the windshield wiper arms, cowl panel and the passenger-side interior kick panel trim following the procedures in the applicable Service Manual.
5. Using the illustrations below for reference, pour water into the cowl area drain (circled in red) and watch for it to appear at the 10mm hole (circled in blue) in the passenger-side kick panel area. If the leak is confirmed as described, proceed with this repair procedure. If not, the source of the leak is most likely elsewhere.
