SERVICE BULLETIN

APPLICABILITY: 2015-2017MY Legacy

NUMBER: 12-226-17

SUBJECT: Fuel Door Sticking Closed in Cold Weather

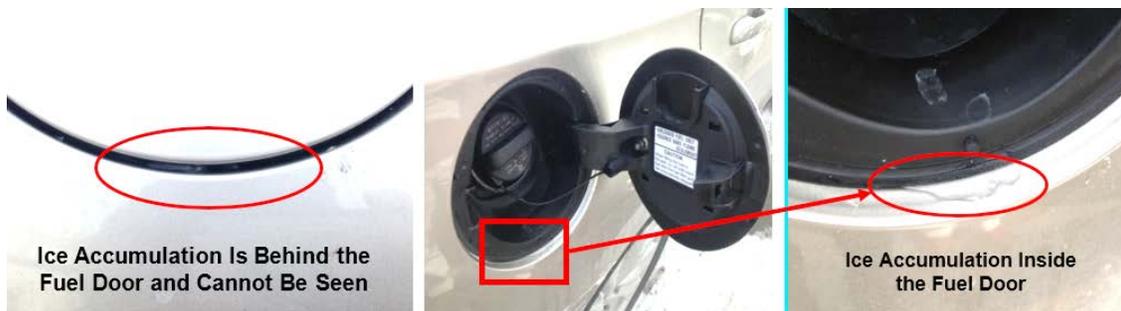
This bulletin provides part number and design change information regarding the fuel door (saucer) assembly which may not open properly due to ice accumulation in sub-freezing conditions.

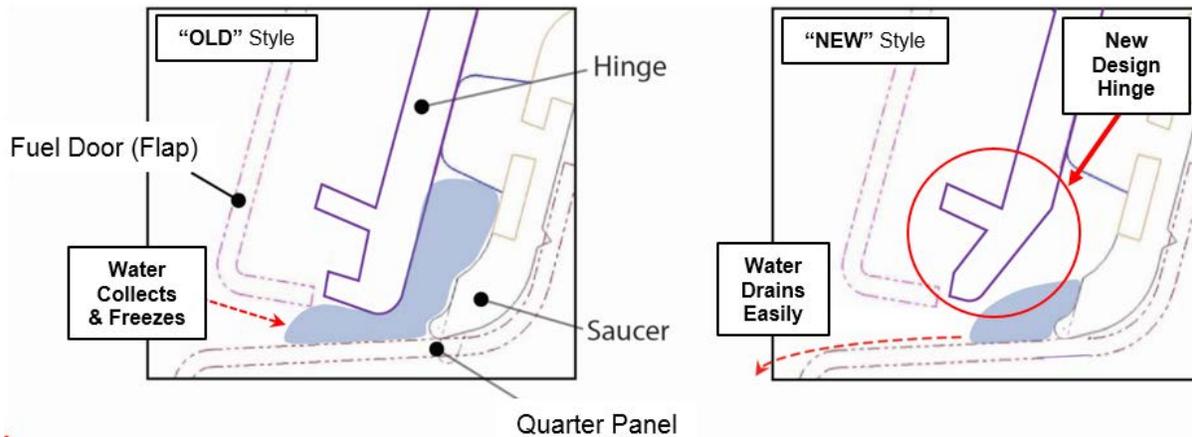
The part number for the new “SAUCER COMPLETE SDN” is: **51478AL01D**. The illustrations below provide a comparison between the “NEW” and “OLD” -style parts. The change involves a change made to the base of the hinge portion to improve drainage and prevent water accumulation. In sub-freezing temperatures, ice can form causing the fuel door to not open properly.

When replacement of the saucer assembly is required, follow the repair procedure outlined in the applicable Service Manual.
