SERVICE INFORMATION

APPLICABILITY: 2018MY Forester Models **NUMBER:** 12-227-17

SUBJECT: Upper Front Grille- Design Change **DATE:** 08/29/17

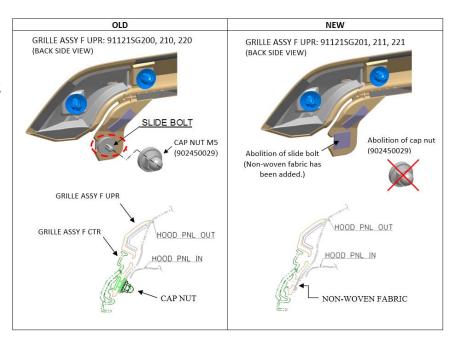
As shown in the detail illustrations to the right, the following new FRONT GRILLE ASSEMBLY, UPPER part numbers now have non-woven tape applied over the slot where the bolts /cap nuts were used previously:

- 91121SG201
- 91121SG211
- 91121SG221

- If the replacement grille being used <u>has non-woven material covering the slide bolt slot</u>, there is no need to install the slide bolt / cap nut.
- If the replacement grille being used <u>DOES NOT have non-woven material covering the slide</u> <u>bolt slot</u> and utilized a slide bolt / cap nut, they must be reused or replaced if damaged or missing.
