SERVICE BULLETIN

APPLICABILITY: 2017MY Impreza

NUMBER: 12-228-17

SUBJECT: Misalignment between Door Trim and Instrument Ornament Panel

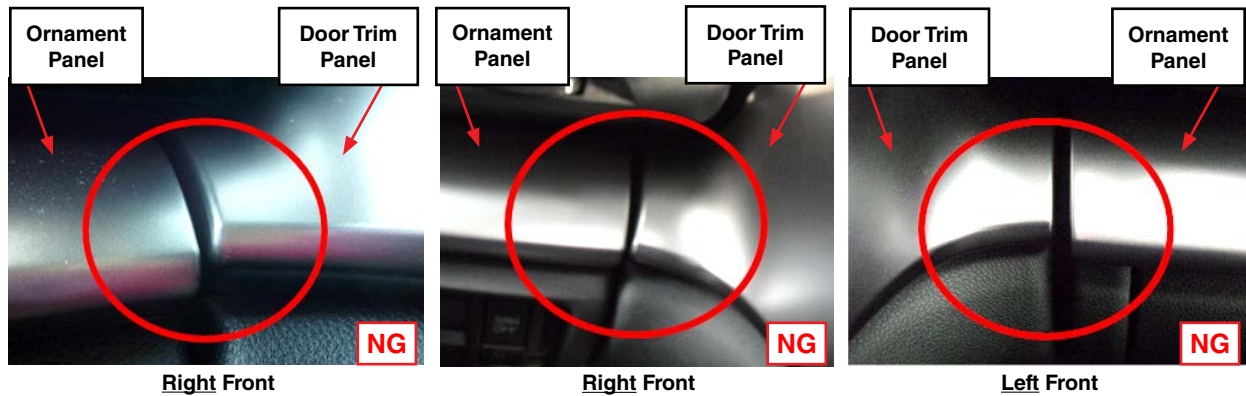
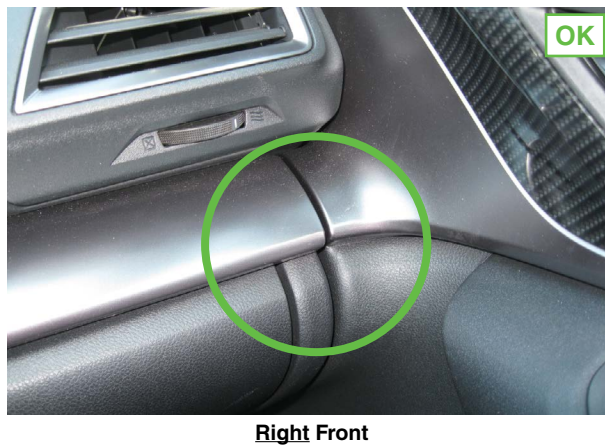
This bulletin provides a repair procedure to address a small number of customer reports of improper fit or misalignment between the front door trim panel and the instrument panel's (IP) ornament panel (garnish) as shown in the example (NG) photos and **Step 1** of the Service Procedure provided below.

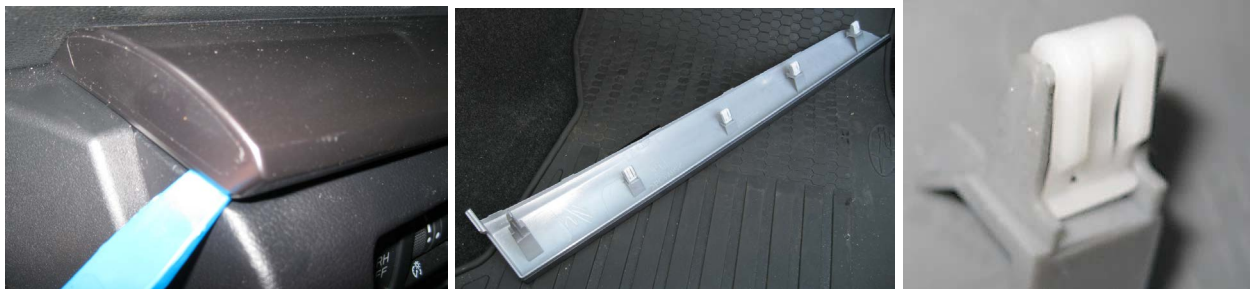
STEP 1:

1. IP ornament panel (garnish) retaining clip(s) not properly inserted and / or trim not fully seated.
2. Door trim panel retaining clip(s) not installed properly and / or improper application of the foam rubber sealing cover on the inside of the door structure. When this cover is out of position, the center retaining clip does not secure the door trim panel properly and can cause misalignment.

Using a plastic trim tool, **CAREFULLY** remove the affected IP ornament panel to confirm proper seating. The longer right side has separate retaining clips attached to it while the driver's side has the retaining clips molded directly into the part. Verify the retaining clips are all fully seated on the trim.
