TSIB 17-01 Rev A		June 30, 2017
TO:	All Operators	
TITLE:	Recommended maintenance for flexible coolant hoses located above the electronic equipment enclosure.	
APPLICABILITY:	All New Flyer Xcelsior buses with rooftop mounted Thermo King or MCC HVAC units

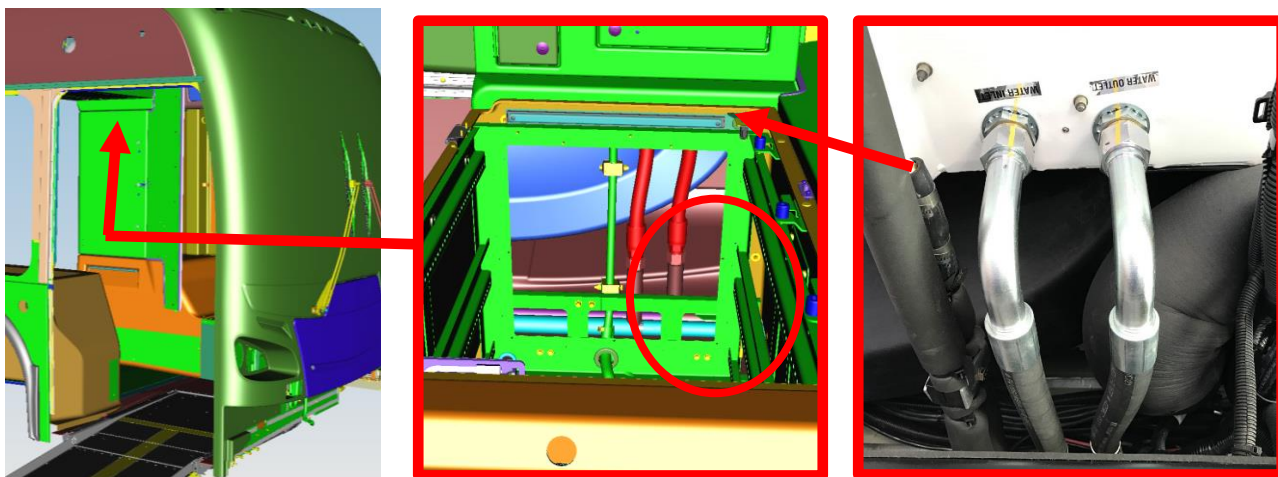
New Flyer has observed instances of the coolant lines, located above the electronic equipment enclosure, failing in years four (4) through five (5). The electronic equipment enclosure is located behind the driver. Some failures of the hose can cause coolant to flow onto the electronics located below the hoses on shelves. In some cases hose failure has caused damage to the electronics, requiring their replacement.

Figure 1: View looking up into the electronic equipment enclosure. Subject hoses shown circled. Parts removed for clarity.

It should be noted that the coolant lines were never expected to last the lifetime of the bus. To prevent potential damage to sensitive electronics New Flyer recommends a yearly inspection of the hoses, and replacement at year four (4).

For additional security you may wish to install a length of corrugated hose (NF PN 278496) over each line when replacing them.
