Vantage Mobility International

Document Number: TS-WI-0225

ASSEMBLY AREA	Tech Service
MODEL	2017 Pacifica RU Touring and Touring L

It has been determined by VMI that converted Chrysler Pacifica's **prior to July 5 2017**, may have not been wired correctly to accommodate the interchangeable seat option. This is in evidence **ONLY** when the driver's seat is powered and the passenger front seat is manual. This document provides detailed instructions for Technicians to add the necessary power and ground wire for interchangeable seating. This document also includes instructions on how to provide this circuit with a more secure ground. **If your van has power seats on both driver and passenger you may still want to update the ground.**

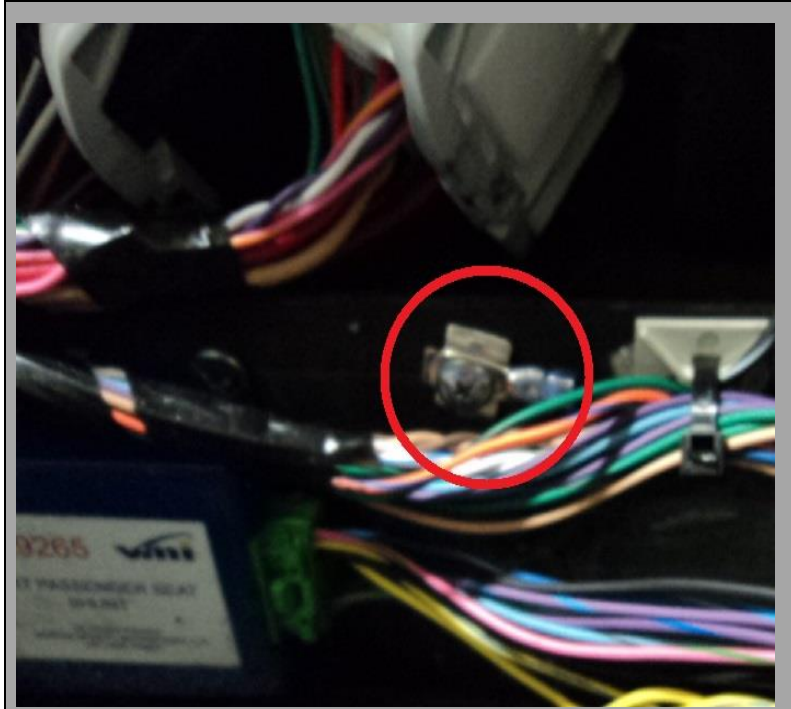
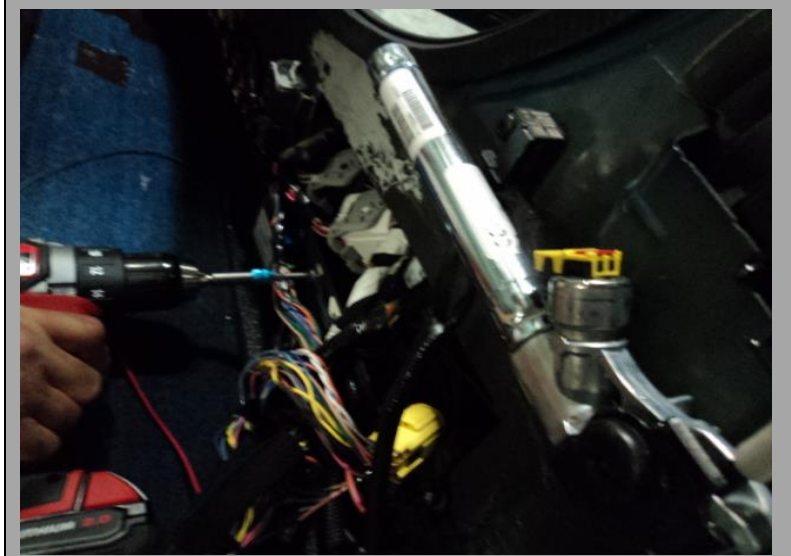
10. Check the ground wire, if it has a self-tapping screw remove the screw and discard the screw. It will be replaced with the bolt, washer and nut supplied.

Note: If the van has both power driver and passenger seating and the ground is attached with a bolt proceed to step #25 reinstalling the panels. If the ground wire is attached with a screw proceed to #11
