## Technical product information

| <b>Topic</b> | V8T-Oil leak between engine and gearbox |
| <b>Brand</b> | Bentley |
| <b>Transaction No.</b> | 2042494/2 |

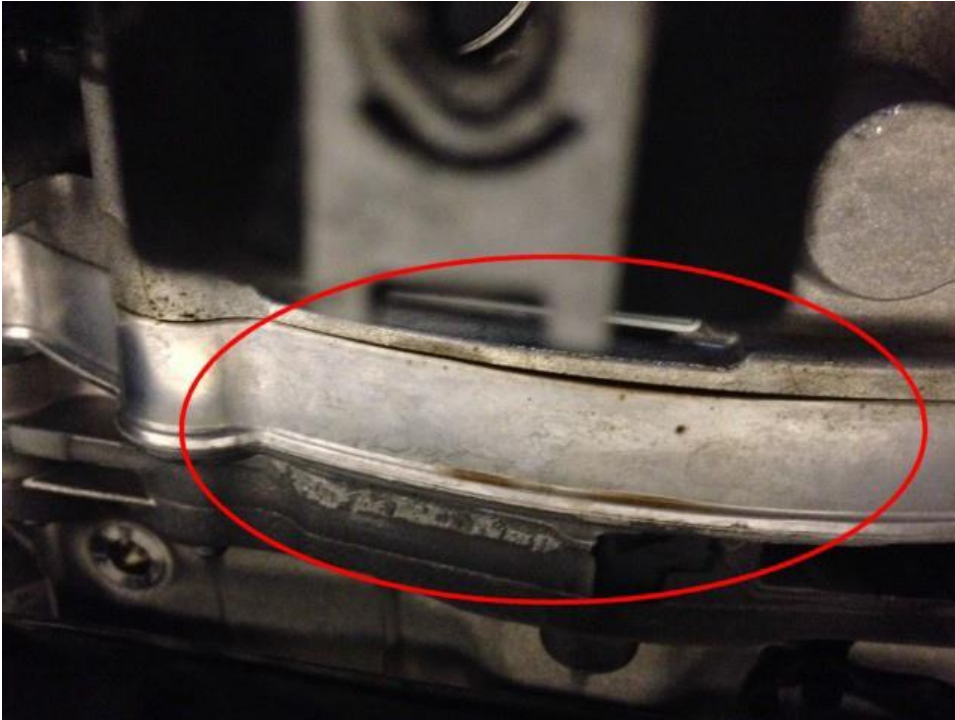
Figure 1

Oil loss via thread of fasteners in crankshaft used to attach torque convertor drive plate/flywheel. New bolt specified with thread sealer pre applied, part number WHT005487A.

Oil is evident at interface between the engine and gearbox (see Figure 1)

Identify precisely the source of the oil leak. If necessary photograph the area then, clean the engine and reassess the vehicle after a test drive (see Figure 1)

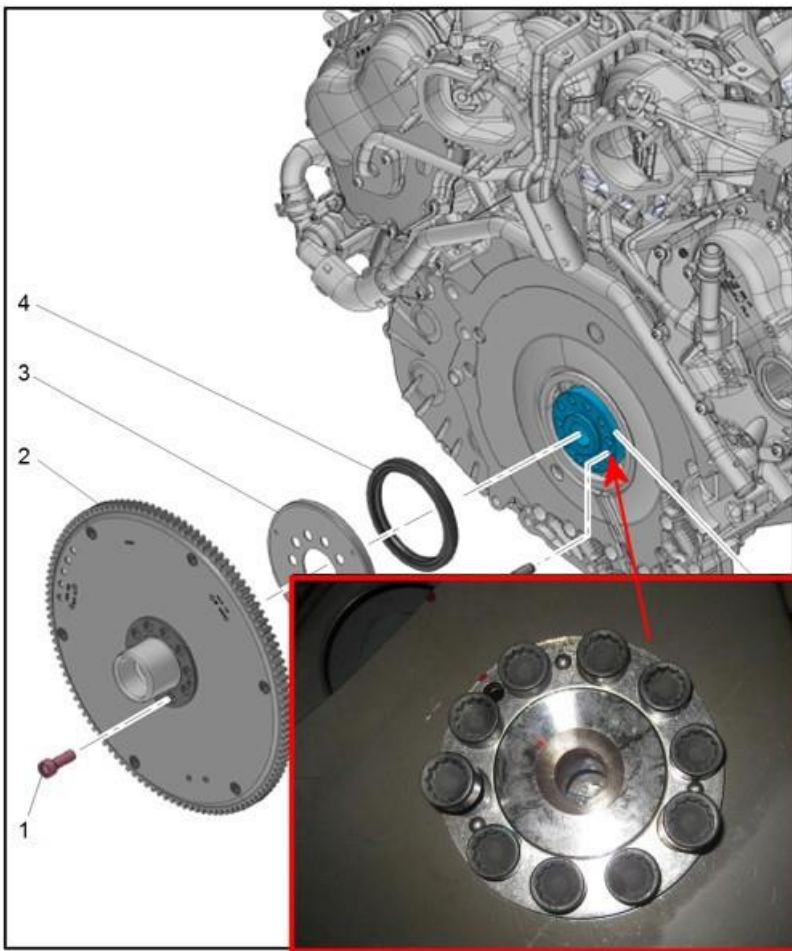
Figure 2

This TPI is to be used to remedy oil found to be leaking through the threads of the fasteners (1) securing the flywheel/flex plate (2) to the rear of the engine crankshaft (see Figure 2)

1. Once it is identified that the oil is originating from inside the bell housing then remove the engine and gearbox and flywheel/flex plate Ref workshop manual Rep.Gr13 – Flywheel – To remove and fit.
