## In This Issue

## Vehicle Technical Info

**TIN-17-23-001: REQUIRED PROCEDURES AFTER CVT ASSEMBLY REPLACEMENT** — 2008-17 Lancer, 2014-17 Mirage, 2017 Mirage G4, 2008-17 Outlander, 2011-17 Outlander Sport/RVR.

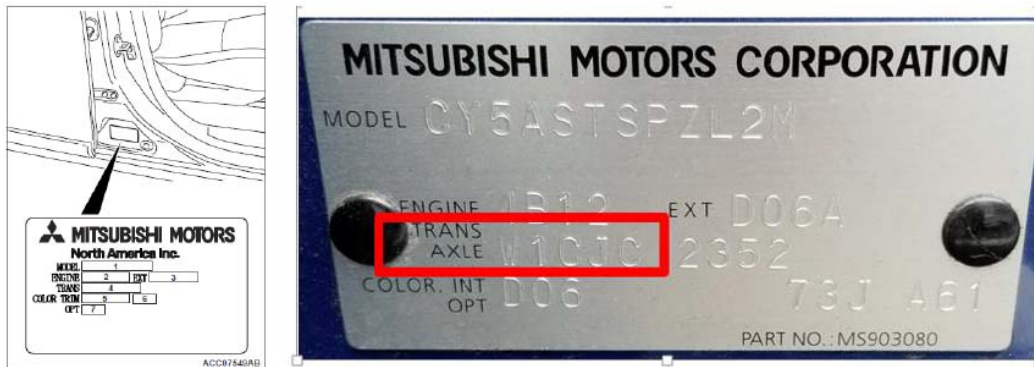
### **CVT TRANSMISSION IDENTIFICATION**

The CVT assembly type must be identified correctly in order to apply the correct procedures after replacement. Incomplete or improper procedures will lead to poor shift performance, complaints from customers, return repairs, and possible transmission damage. The correct transmission can be identified from the information plate on the passenger or driver’s side B pillar, depending on model and model year (see illustration below). For example: the transmission identified on this plate is a W 1 C J C which, according to the chart on the first page, is a CVT 8 AWD.

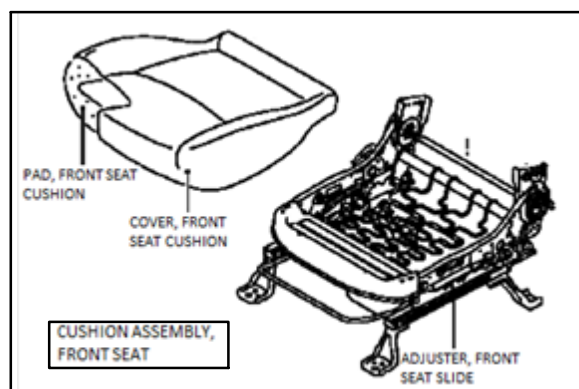
✓ **FRONT SEAT SLIDE ADJUSTER REPLACEMENT** — 2011 & up Outlander Sport/RVR.

If the front seat slide adjuster requires replacement for any reason (OCM or seat weight sensor failure, problems with manual/power seat adjustment, etc.), replace the front seat slide adjuster **only**. The front seat cushion pad and cover is transferable to the new seat adjuster.
