| <b>Subject</b> | 2018 FIT - Honda Sensing Light Flashing at PDI - No DTCs |

To: All Honda Service Managers/Advisors  
From: Technical Research and Service (TRS)  
RE: **\*\* Inspection Request \*\*** 2018 FIT - Honda Sensing Light Flashes at PDI / No DTCs

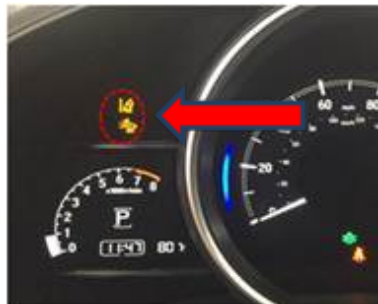
American Honda (AHM) discovered that certain 2018 FIT vehicles may have the Honda Sensing Light flashing at ignition II position during PDI (as seen below) and your dealership might have received affected vehicles. Please check the attached VIN list and inspect the vehicle(s) if still in your inventory.

If you have a VIN with this symptom, please contact Kyle Matsuoka at Technical Research & Support (TRS) Group at 1-800-880-1072 for further action. Also, if the vehicle has been dealer traded or sold to a retail customer, please contact Kyle immediately.
