**HYUNDAI**NEW THINKING.
NEW POSSIBILITIES.**Technical Service Bulletin**

GROUP	NUMBER
CAMPAIGN	17-01-001
DATE	MODEL(S)
JANUARY 2017	ELANTRA (AD)

SUBJECT: 2017 ELANTRA (AD) CONSOLE ARMREST COVER INSPECTION AND REPLACEMENT (SERVICE CAMPAIGN T1P)

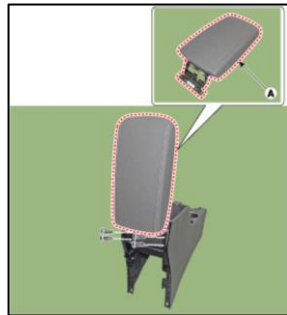
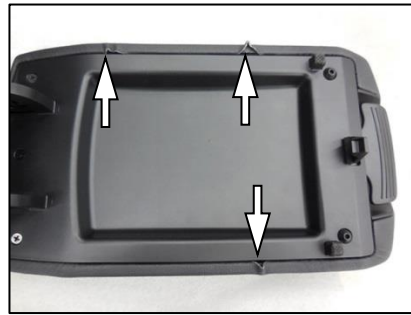
Description: This bulletin describes the procedure to inspect and replace the floor console armrest if the cover material is found to be peeling. This peeling condition was caused during the cover material cutting process.

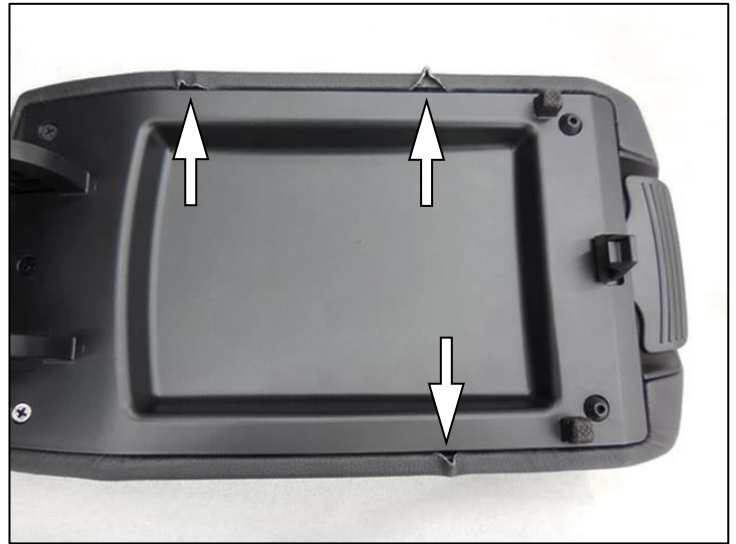
1. Open the floor console armrest cover. Visually inspect the underside for material peeling as shown.

Note: The arrows point to examples of a defective cover material.

- 1) If the cover material is found to be OK (material is tightly attached to the housing), no further service procedure is required. **Use Labor Op Code: 60C074R2.**
- 2) If the cover material is found to be peeling similar to shown in the picture, replace the console armrest with a new one according to the procedure below.
