HYUNDAI NEW THINKING. NEW POSSIBILITIES. Technical Service Bulletin	GROUP CAMPAIGN	NUMBER 17-01-010
	DATE JANUARY 2017	MODEL(S) Santa Fe (NC) Tucson (TL)
SUBJECT: ELECTRONIC STABILITY CONTROL (ESC) MODULE LOT # INSPECTION AND REPAIR (SERVICE CAMPAIGN T1J)

This TSB supersedes 16-01-065 to include repair procedures for vehicles with affected lot number ESC modules.

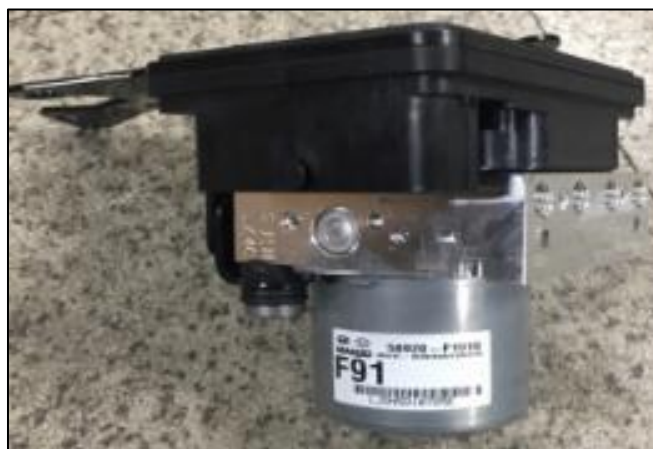
Description: This bulletin describes the service procedure to inspect the lot number of the electronic stability control (ESC) module of certain Santa Fe (NC) and Tucson (TL) vehicles. Parts from the affected LOT number may have damaged bolts which hold the ECU to the solenoid block. Vehicles with affected LOT number ESC modules must be inspected for damaged bolts. If the bolts are intact, they must be replaced. If the bolts are damaged, the HECU assembly must be replaced.

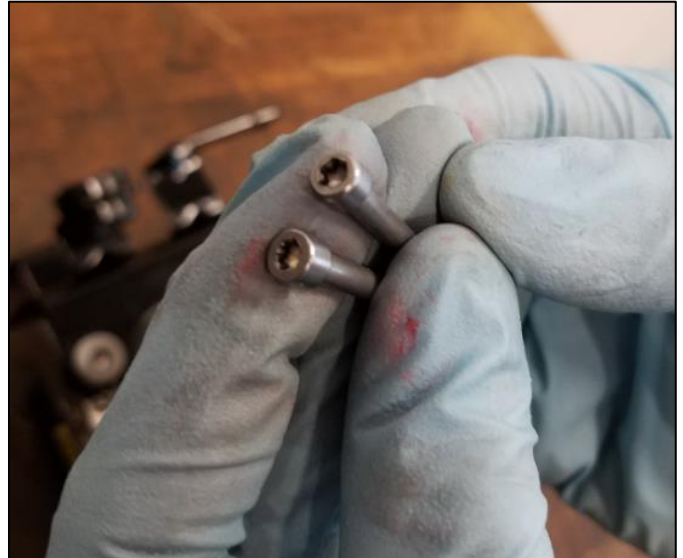
Upon removal, inspect the bolts for damage:

- If the bolt heads are damaged, replace the HECU continue to step 19.
- If the bolt heads are not damaged, replace the bolts with new ones and reassemble the vehicle in reverse order of removal to complete the service procedure. Use labor operation code **60C117R3**.

If new bolts are needed, use a small inch-lb torque wrench to install and torque the bolts to spec. 27.6 ~ 33.6 inch-lb.

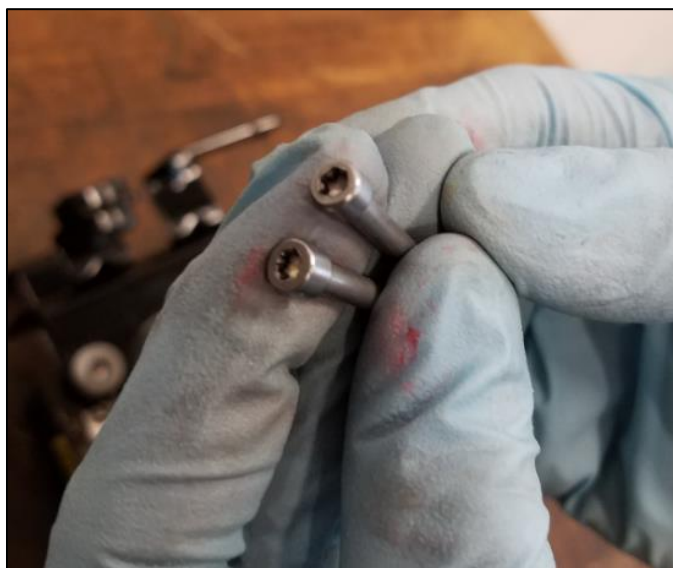
3. Upon removal, inspect the bolts for damage:

- If the bolt heads are damaged, replace the HECU continue to step 4.
- If the bolt heads are not damaged, replace the bolts with new ones to complete the service procedure. Use labor operation code **60C117R1**.

If new bolts are needed, use a small inch-lb torque wrench to install and torque the bolts to spec. 27.6 ~ 33.6 inch-lb.
