HYUNDAI NEW THINKING. NEW POSSIBILITIES.	GROUP CAMPAIGN	NUMBER 17-01-002
	DATE JANUARY 2017	MODEL(S) SANTA FE SPORT (AN)
Technical Service Bulletin		
SUBJECT: FUEL FILLER CAP REPLACEMENT (SERVICE CAMPAIGN T1Q)

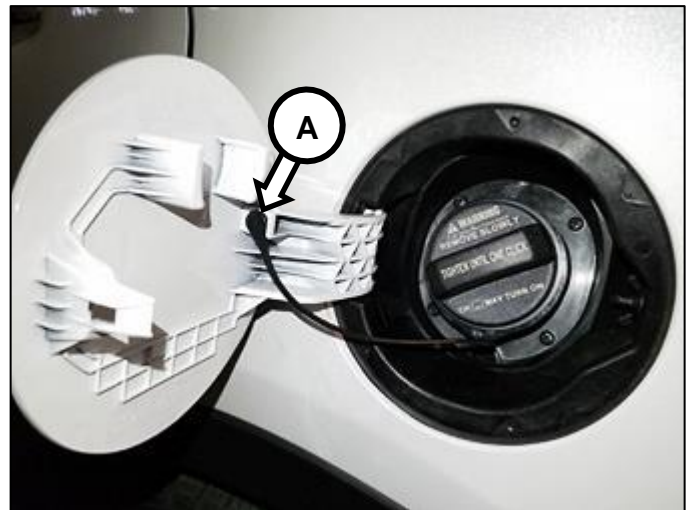
Some 2017MY Santa Fe Sport (AN) vehicles may have the condition where the fuel filler cap seal may not provide proper sealing and trigger the Check Engine Light with the following DTC(s).

- P0442: Evaporative Emission System - Leak detected (Small Leak)
- P0456: Evaporative Emission System - Leak detected (Very Small Leak)

1. Open the fuel door.

Unclip the fuel filler cap lanyard (A) from the fuel door.

Unscrew the fuel cap from the vehicle.

Install a new fuel cap in the reverse order of removal.
