# NEWMAR CORPORATION

## PRODUCT INFORMATION BULLETIN

| DATE ISSUED | MODEL YEAR(S) AFFECTED | PIB # |
|---|---|---|
| 8/31/2017 | 2017 | 489 |

Spartan Motors has issued Campaign Service Bulletin (CSB17-250-003) for 2017–2018 model year K2 model coach chassis equipped with an Independent Front Suspension supplied by Reyco Granning. These chassis were built between January 17, 2016, and March 16, 2017. In response, Newmar Corporation is publishing PIB 489.

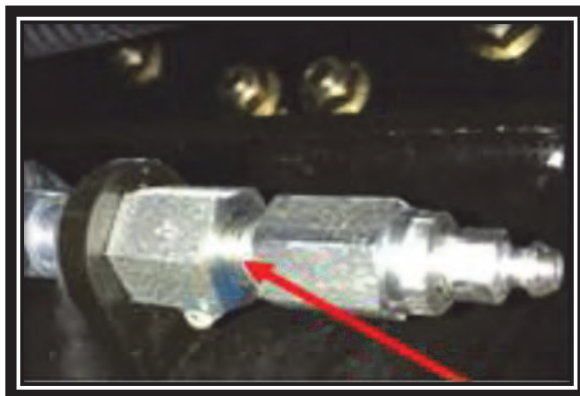
**FIG. 2-1**

Locate the steering bleeder assembly at front of cradle and inspect for thread sealant. Refer to FIG. 2-1.

1. If sealant is present and no leak is visible proceed to step 7.
2. If no sealant is visible or connection is leaking follow repair instructions below.

NOTE: apply PTFE/Teflon Thread Sealant Tape Premium, rated to 10,000 psi. (Example: LA-Co 44095 Slic-tite or similar).
