JTB00542NAS1

TECHNICAL BULLETIN

Oil Leak From Transmission Threaded Boss

MODEL:	MODEL YEAR:	VIN:	ASSEMBLY PLANT:	APPLICABILITY:
XE (X760)	2016- 2017	900000- 942577	Solihull	Vehicles With: 8HP45 8-Speed Automatic Transmission RWD
XF (X260)	2016- 2017	Y00001- Y27214	Castle Bromwich	Vehicles With: 8HP45 8-Speed Automatic Transmission RWD

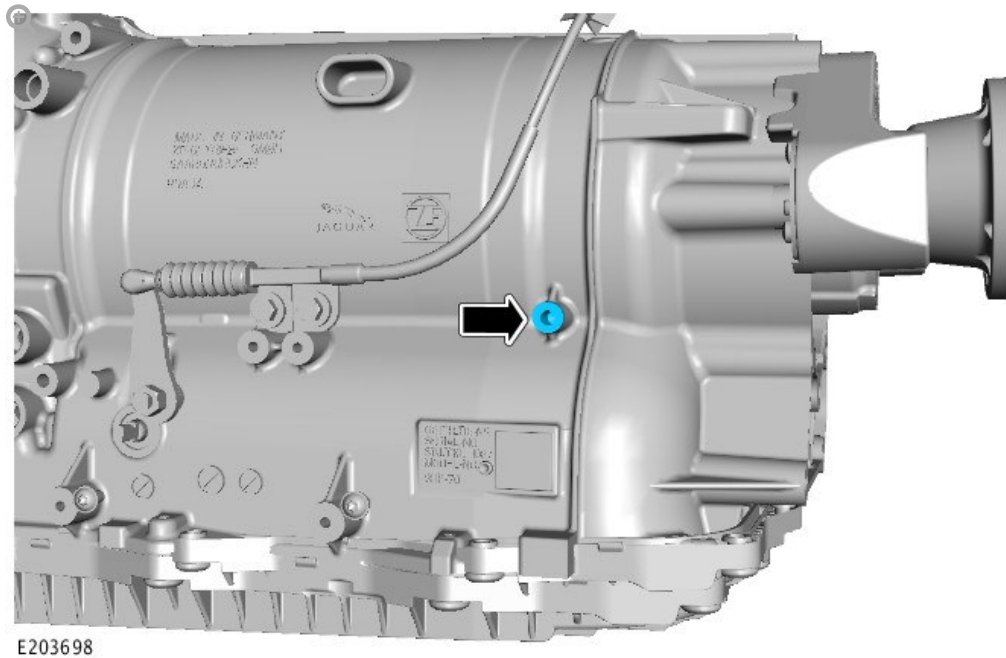
An oil leak from the underneath of the vehicle may be evident. Upon further inspection, the oil leak appears to be coming from the transmission threaded boss.

This may be caused by thermal expansion between the transmission aluminum casing and the embedded steel tube, causing the threaded boss area to become porous.

Identify the root cause of the oil leak (see TOPIx Workshop Manual section 307-01: Automatic transmission/transaxle - Vehicles with: 8HP45 8-Speed automatic transmission RWD).

- 1 If the oil leak is not from the area shown, do not continue with this Service Instruction.
 - Continue diagnosis using the TOPIx Workshop Manual.
- 2 If the oil leak is from the area shown, go to Step 3.

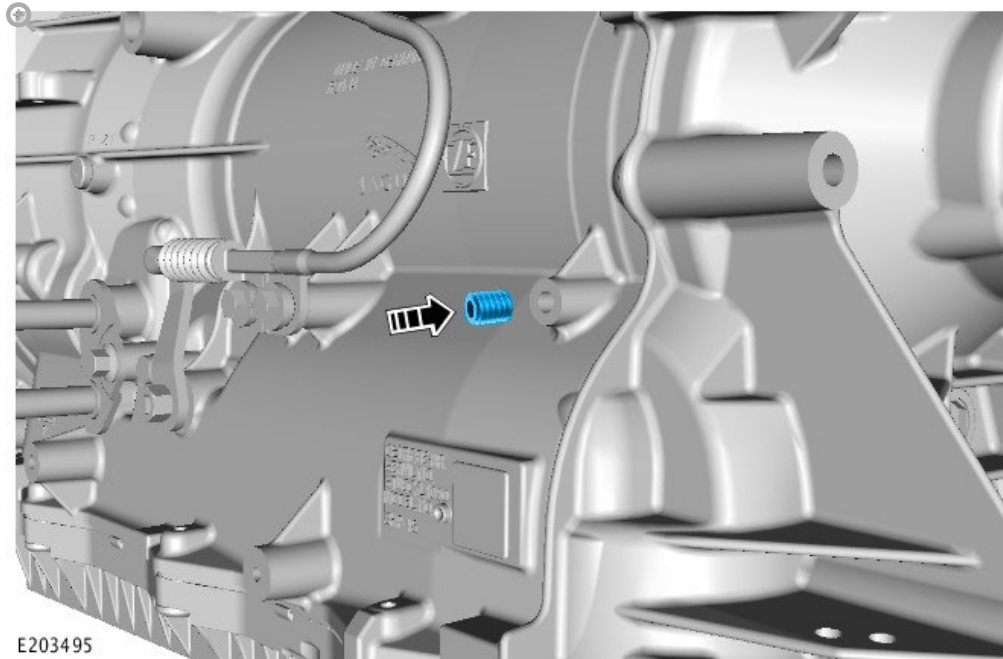
4

The area must be clean and free from foreign material.

3 Apply Loctite® 542 or equivalent to the new grub screw.

Install the new grub screw.

- Torque: **10 Nm.**
