# Preliminary Information

## PIP5390B Malibu 5ET50 (MKE) Hybrid Transmission and Component Restriction Program

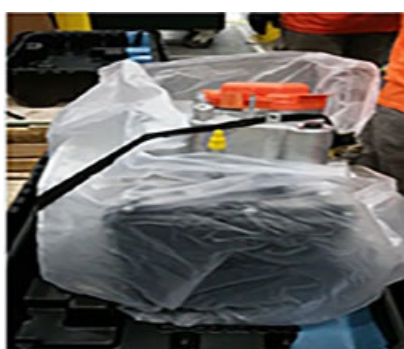
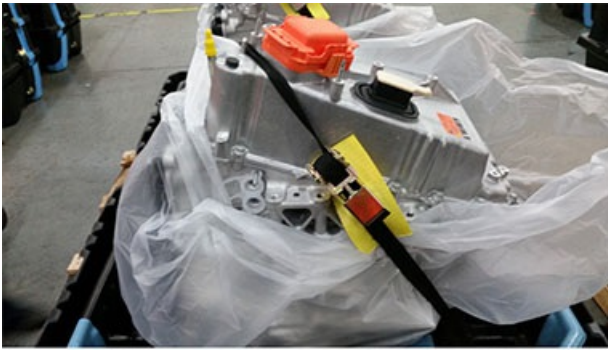
Please make sure that you are strapping the transmission down. Most of the transmissions are being returned have sustained damage from shipping.

Position the strap as shown in the pictures below and tighten with the ratchet.
