Preliminary Information

PIP5490B Malfunction Indicator Lamp Illuminated With DTC P0300

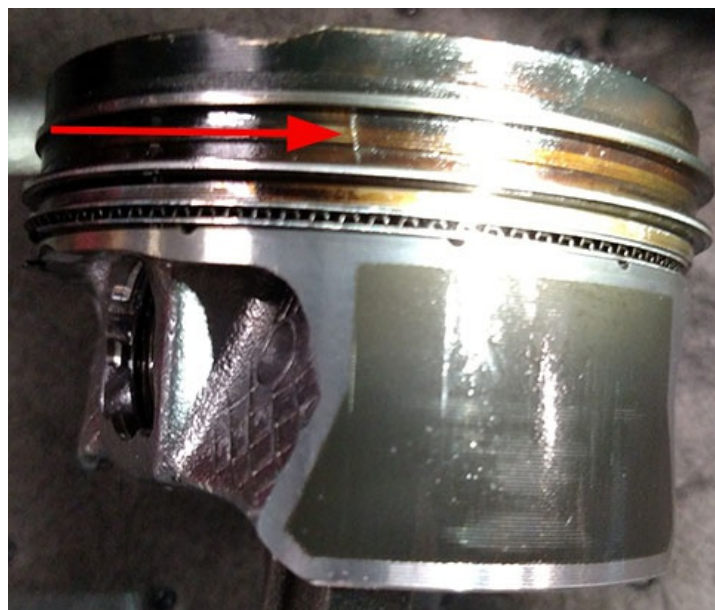
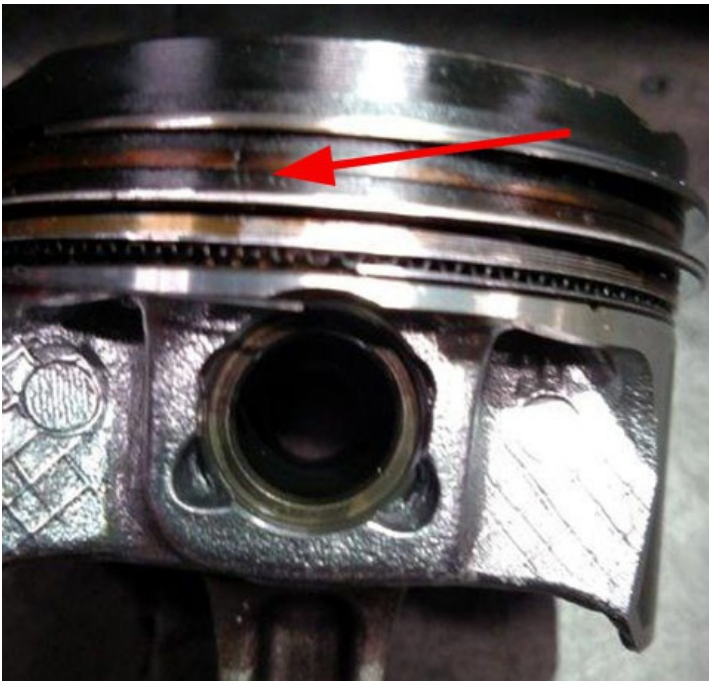
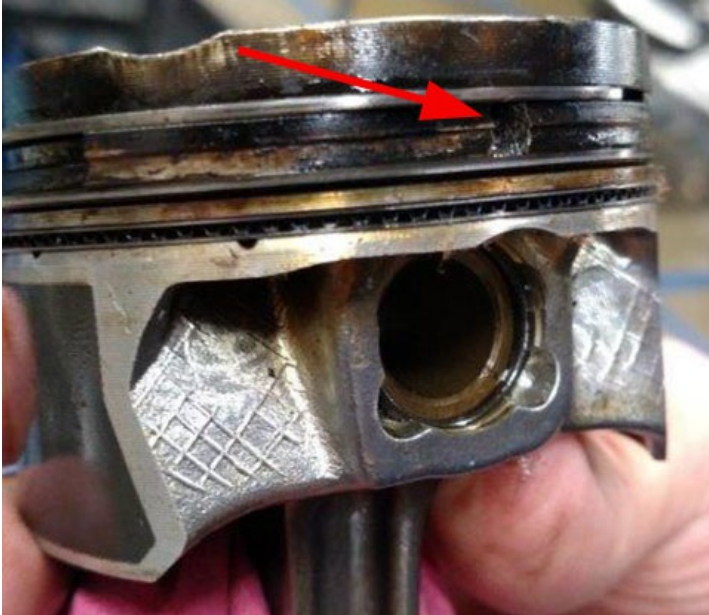
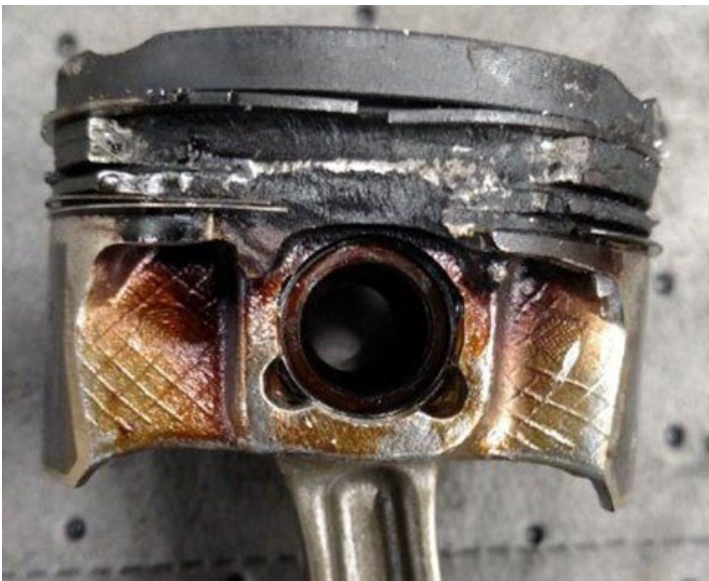
Brand:	Model:	Model Years:	VIN:		Engine:	Transmissions:
			from	to		
Chevrolet	Cruze	2016 - 2017	All	All	1.4L LE2	All
Buick	Encore	2016 - 2017	All	All	1.4L LE2	All
Involved Region or Country	USA, Canada					
Additional RPOs:	LE2					
Condition	Some customers may comment on a rough running engine with the Malfunction Indicator Lamp on. Upon inspection, a technician may find DTC P0300 set along with a misfire and low compression in one or more cylinders.					
Cause	This condition may be caused by a damaged piston requiring replacement.

Shown below are examples of pistons with varying levels of damage.

If the cylinder wall surfaces have not been damaged, replace all four pistons and fill the crankcase with current specification Dexos 1 oil. (refer to latest version of Corporate Bulletin Number [16-NA-367](#)).

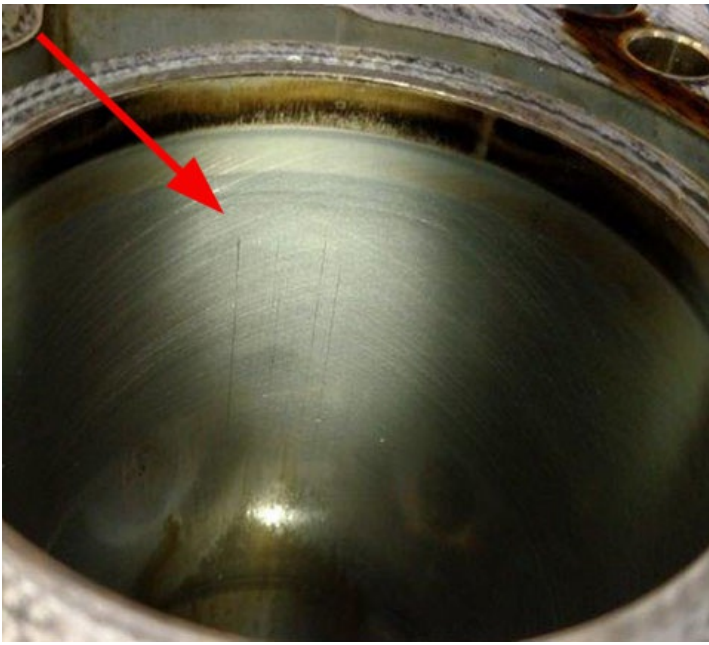
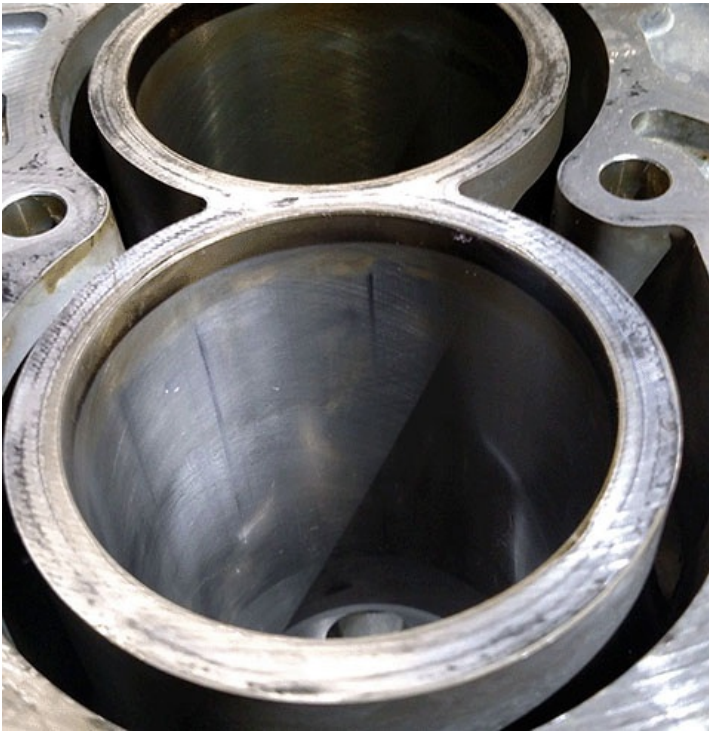
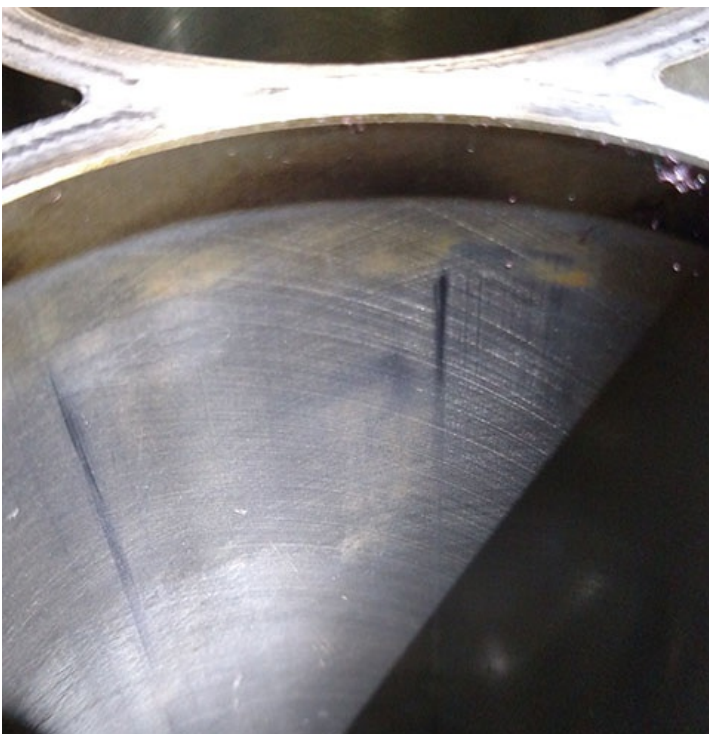
Shown below are several examples of light vertical marks visible on the cylinder wall.

In these examples, none of the marks in the cylinder walls could be felt with the finger tip or nail and engine replacement is not recommended.

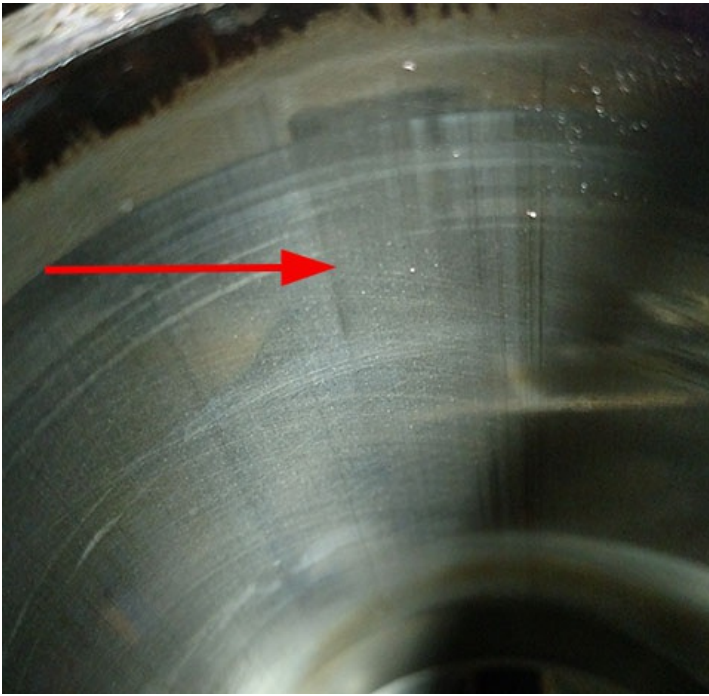
Shown below is an example of a damaged cylinder wall.
In this example the scuffing is wide and has removed the crosshatch from the cylinder wall in the area above the arrow.
This would result in oil consumption and requires engine replacement.
