# Preliminary Information

## PIP5081J (EREV) Whine, Scrape, Whistle Type Noise While Driving

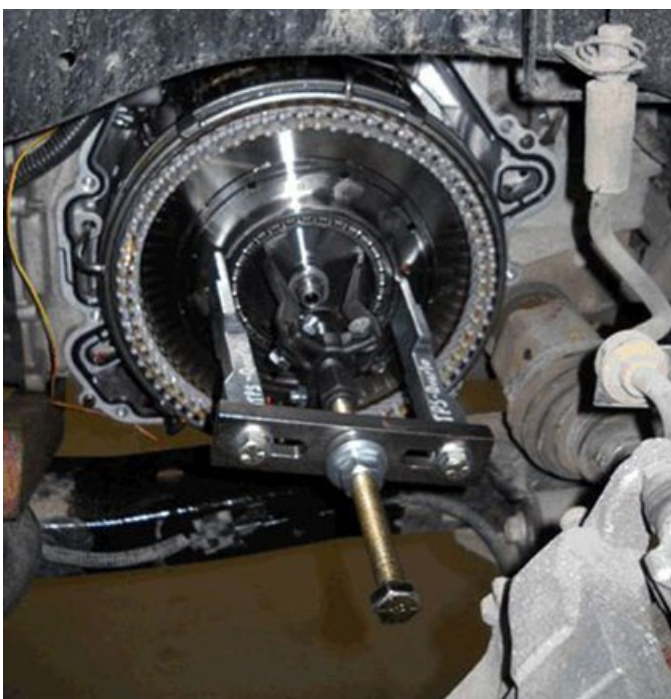
This noise may be caused by a separated electric drive motor B rotor bearing cage. A revised bearing has been released for installation into the drive unit.

#### Important:

Please ensure that the Special Tools DT-47865 - Bearing Remover and J-45124 - Removal Bridge are used to remove bearing. If proper tools are not used the rotor may be damaged leading to a repeat repair. DO NOT TRY TO PRY OUT.
