# Preliminary Information

PIT5501F Steering Feels Loose / Excessive Lash / Fluid Leak At Lash Adjuster

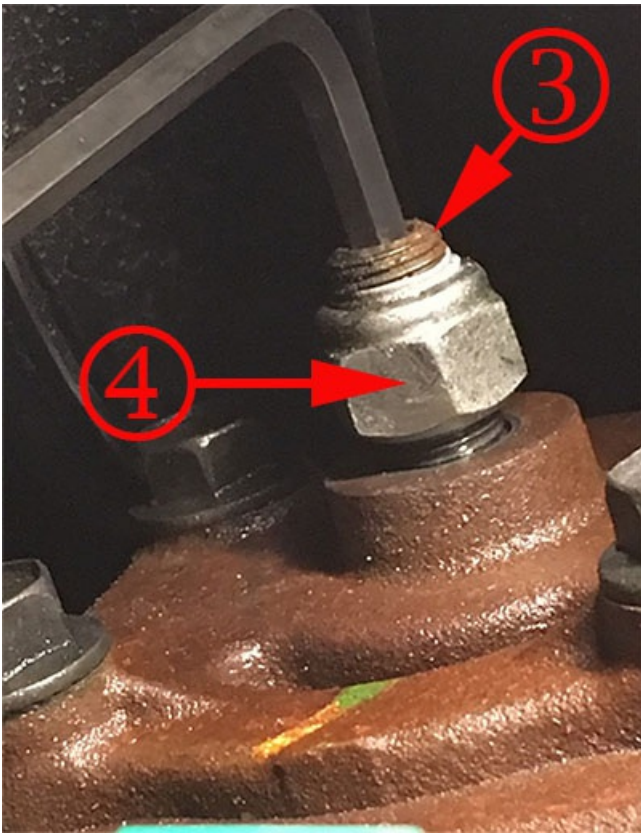
These concerns could be caused by the pitman shaft adjuster stud (3) unthreading up/out of the cover plate, which can cause excessive lash in the steering gear. This issue is NOT caused by the lock nut (4) turning on the adjuster stud (3), shown below.

- The adjuster stud nut (4) will not be seated up against the cover plate, shown below.
- The adjuster stud (3) can easily be turned in or out by hand using an Allen wrench.

If it is found that the pitman shaft adjuster stud (3) has unthreaded up/out AND there is NO reason to believe someone has previously turned the adjuster stud nut (4) on the adjuster stud (3), continue to the recommendations section to apply thread locker on the adjuster stud threads.

If any lash/play is found, OR there IS reason to believe someone has turned the adjuster stud nut (4) on the adjuster stud (3), follow the SI procedure titled "Steering Gear Pitman Shaft Over-Center Preload Adjustment - Off Vehicle (Heavy Duty)".
