Preliminary Information

PIP5495A Check Engine Light On With P0299 Or P0234

Brand:	Model:	Model Years:	VIN:		Engine:	Transmissions:
			from	to		
Buick	Encore	2013 - 2018	All	All	1.4L LUV or LUJ	All
Chevrolet	Cruze	2011 - 2016	All	All	1.4L LUV or LUJ	All
Chevrolet	Sonic	2012 - 2018	All	All	1.4L LUV or LUJ	All
Chevrolet	Trax*	2014 - 2018	All	All	1.4L LUV or LUJ	All

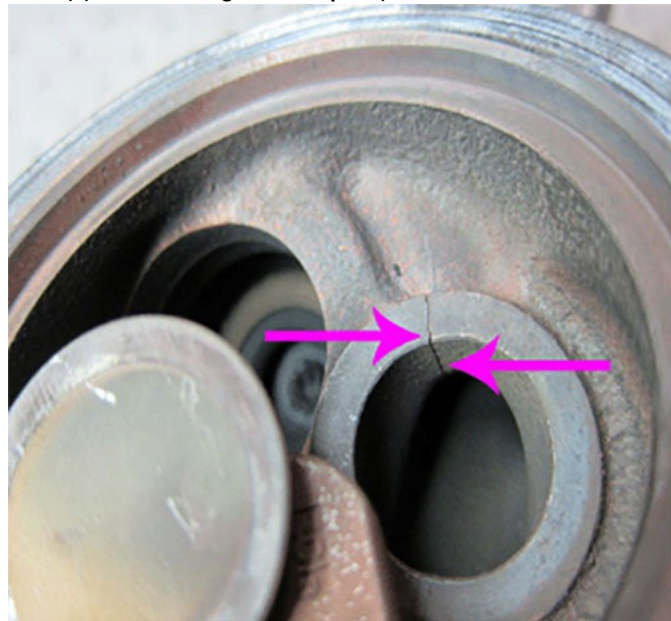
Crack(s) at the wastegate valve port (this is normal and does not affect performance)

Do not replace the turbocharger if P0299 is set and one of the following is present:

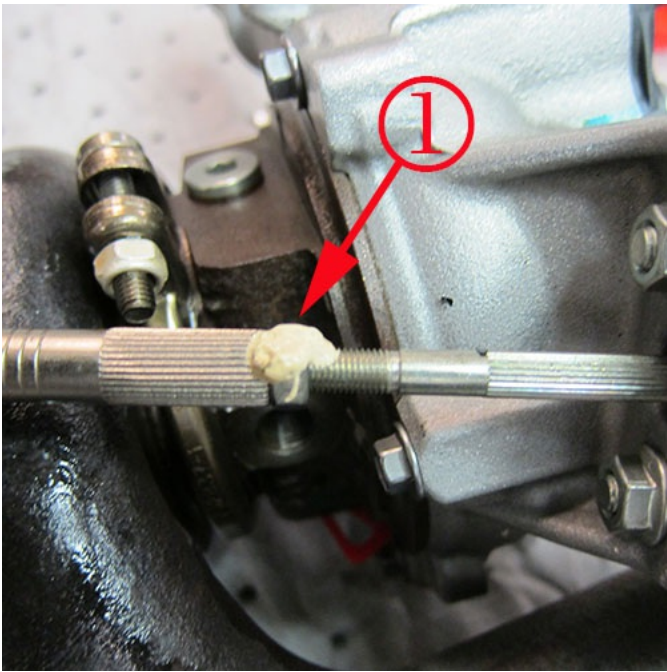
Wastegate solenoid valve port broken (replace solenoid valve - released for service)

Wastegate actuator port bent (replace wastegate actuator - released for service)

Wastegate actuator clip missing (replace wastegate actuator clip - released for service)

Do not replace the turbocharger under powertrain warranty if the tamper paint has been removed, the seal broken, or the actuator has been adjusted.

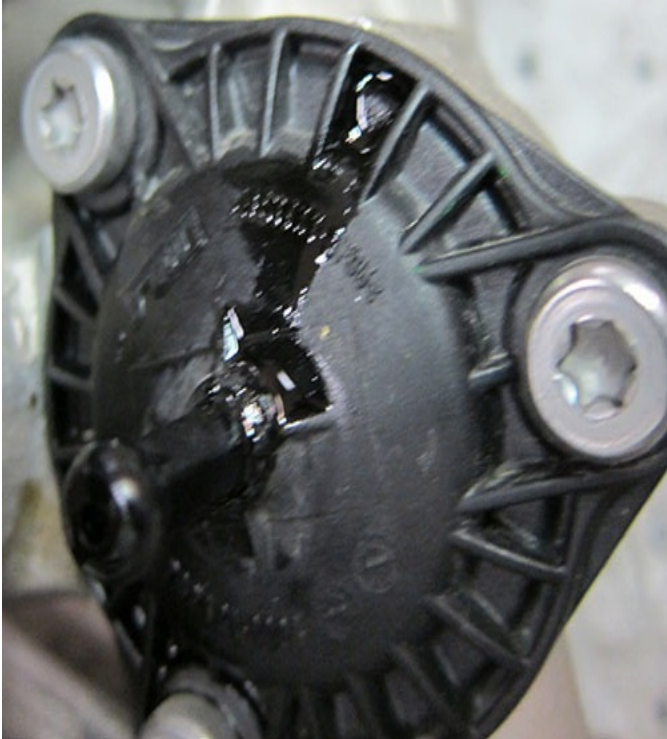
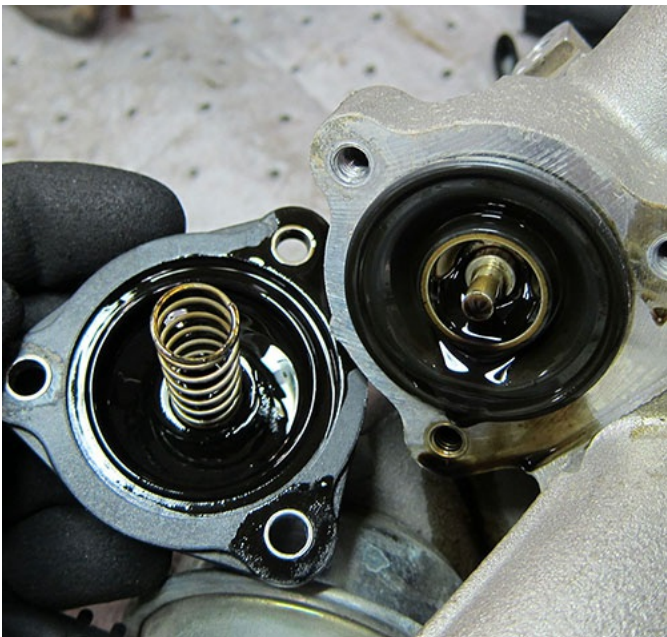
Bypass (recirculation) valve cover port broken or water/oil found inside the valve (clean the components, if necessary replace bypass (recirculation) valve assembly - released for service)

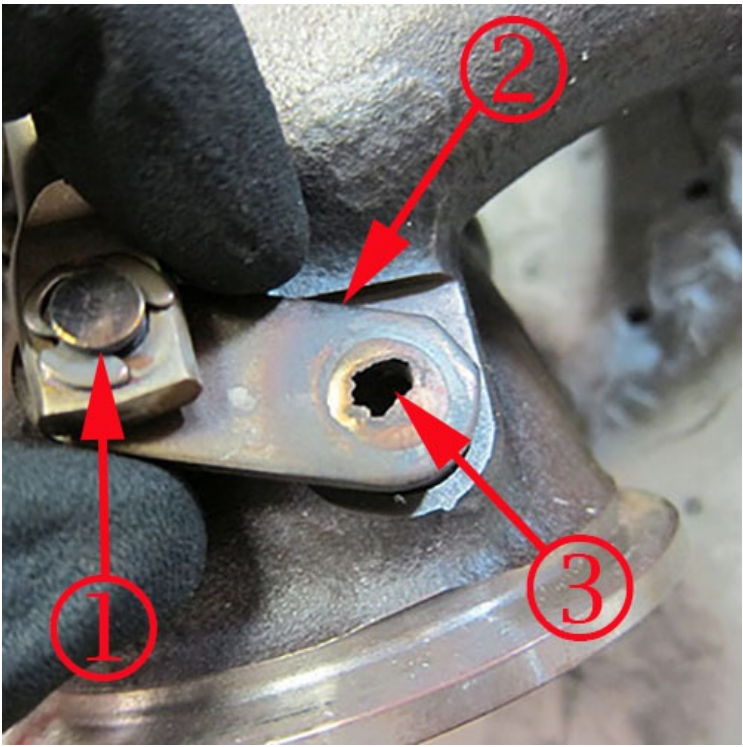
Disconnected wastegate lever arm (crank) (2) from the shaft (3).

Disconnected wastegate lever arm pin (1) from the lever arm (crank) (2).

Replace the turbocharger if P0299 is set and at least one of the following is present:

If the following failures are identified, it is not necessary to perform the Turbocharger Boost Control Test.

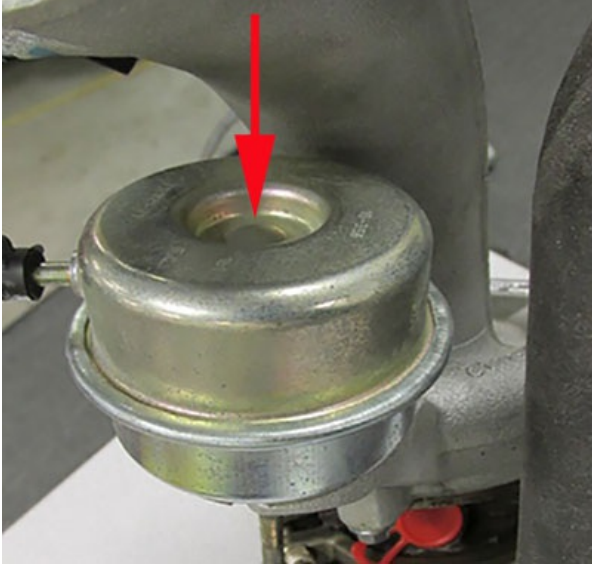
The original equipment wastegate actuator found on 2011 and 2012 model years shown below, has a recessed stop at the head of the actuator.

Original equipment actuator is found on 2011 and 2012 model years.

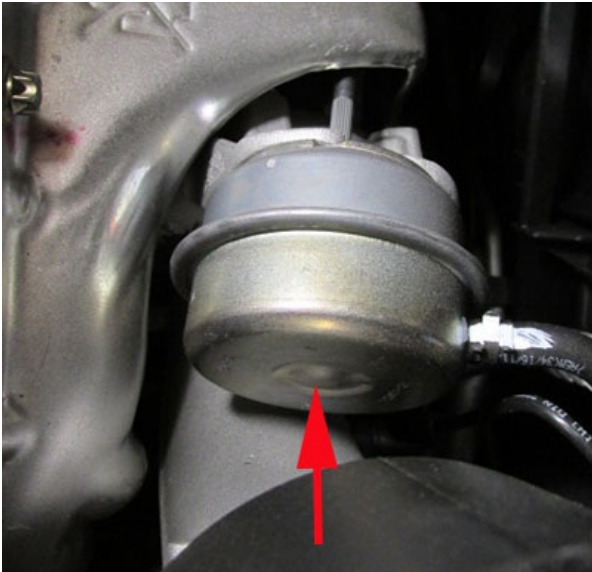
The updated design actuator shown below has a stop that is not recessed and allows 5mm more travel in the closed direction.

With this updated design, it is very unlikely that an insufficient preload issue exists.

Updated design.

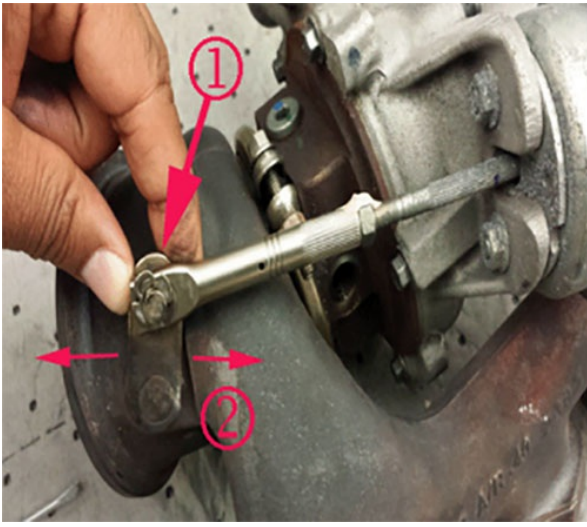
Wastegate Preload Inspection.

Wastegate lever arm (1) moves with little effort in the direction as shown (2) while the actuator rod remains static, see picture below "Wastegate Preload Inspection".

Note: This issue will only be found on 2011 or 2012 vehicles equipped with original equipment turbochargers.

If the lever wiggles with little effort while the actuator rod remains static, the pre-load is insufficient and the turbocharger must be replaced.

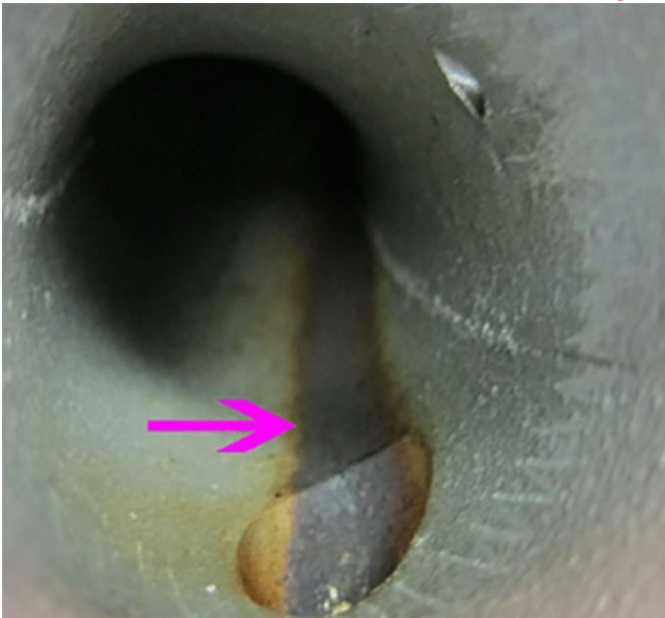
Notice: The view shown below indicates **NORMAL** oil staining in the turbocharger outside air inlet. This dry stain does not represent an oil leak.

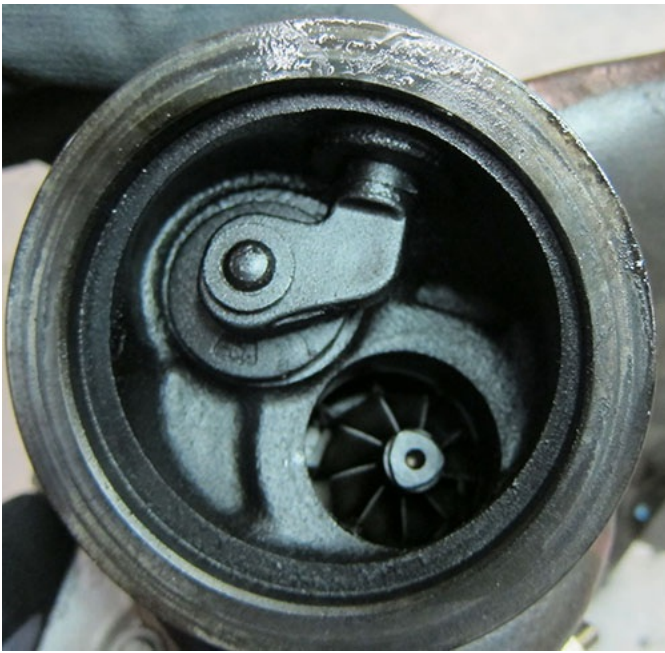
Inspect for the presence of oil in the exhaust system.

If oil is present in the exhaust system, then inspect the turbocharger turbine and compressor wheels to be sure that they are not broken off. It is very unlikely that the turbocharger will leak oil internally if the turbine and compressor wheel shaft is not broken.

Refer to the current publication of [PIP5197](#) for diagnostic tips for oil coming through the exhaust ports or PCV system.

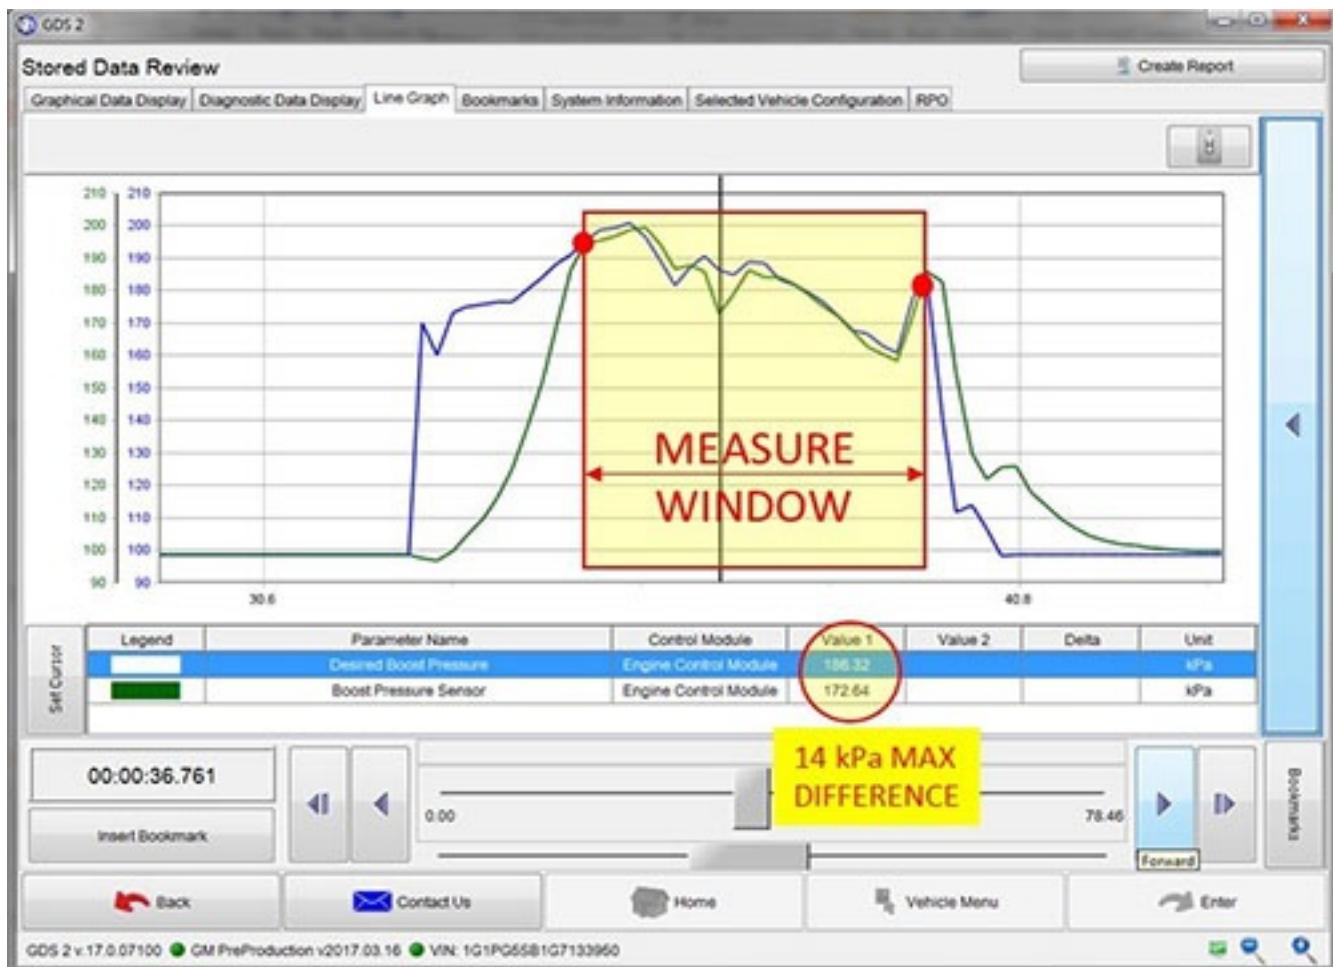
Example of normal turbocharger wastegate operation:

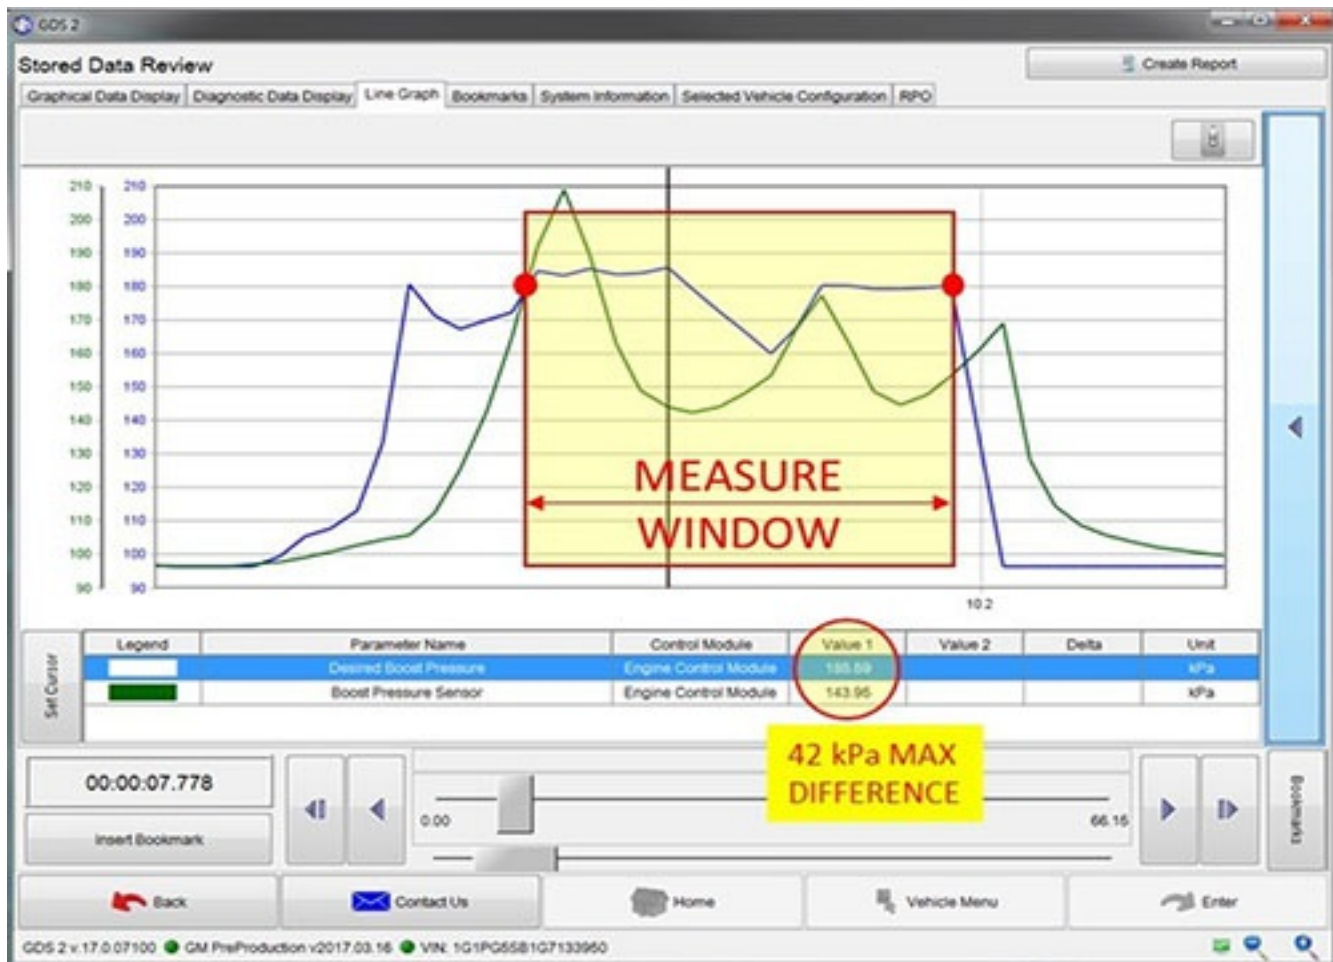
Example of a malfunctioning turbocharger wastegate:
