Preliminary Information

PIP5495B Check Engine Light On With P0299 Or P0234

Models

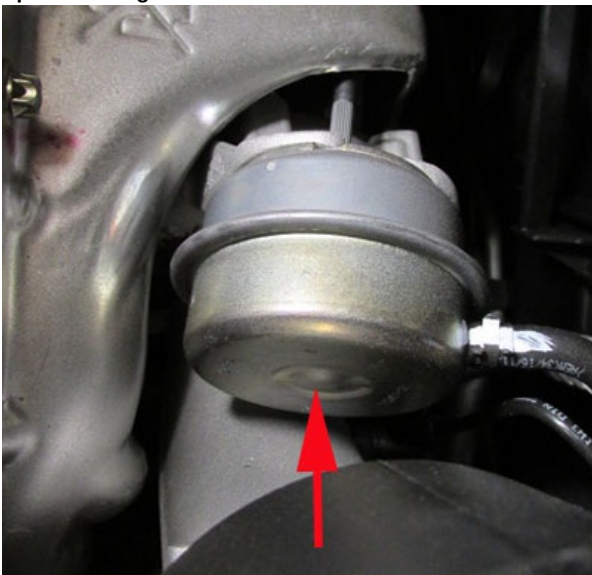
The updated design actuator shown below has a stop that is not recessed and allows 5mm more travel in the closed direction.

With this updated design, it is very unlikely that an insufficient preload issue exists.

Updated design.
