Preliminary Information

PIP5498A SES Lamp P050D P0300 Setting On A Cold Start And/Or a Run Rough Warm with No codes

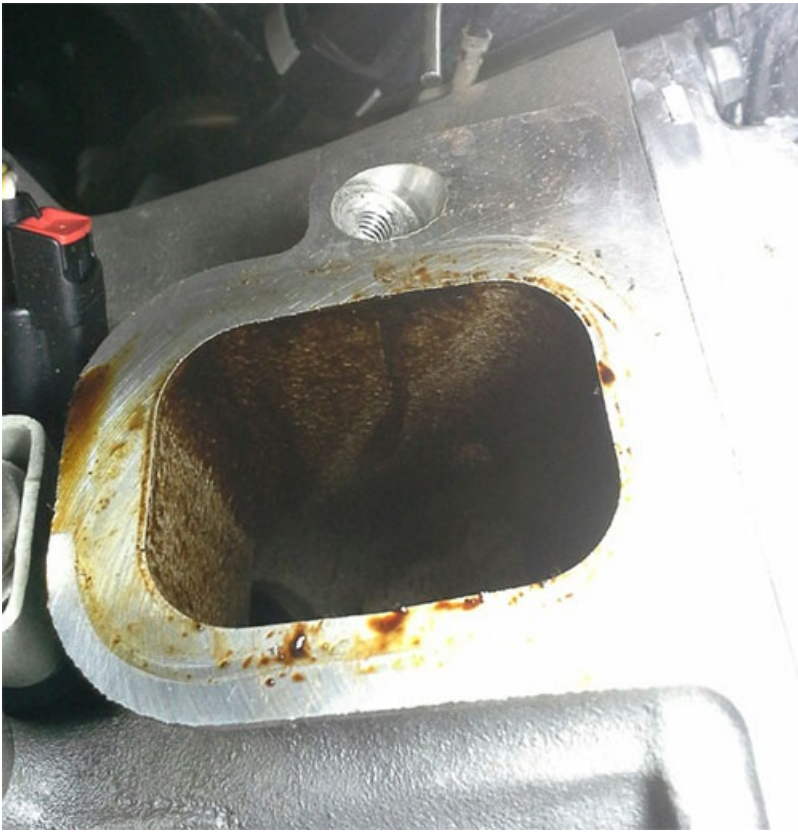
If the head casting line is the concern the intake port will be wet with a coolant oil mix.

This could be the cause of a running rough warm concern with or without codes.

The location of where the coolant is running down in the port will also look washed down.

If this is found the cylinder head will need to be replaced.

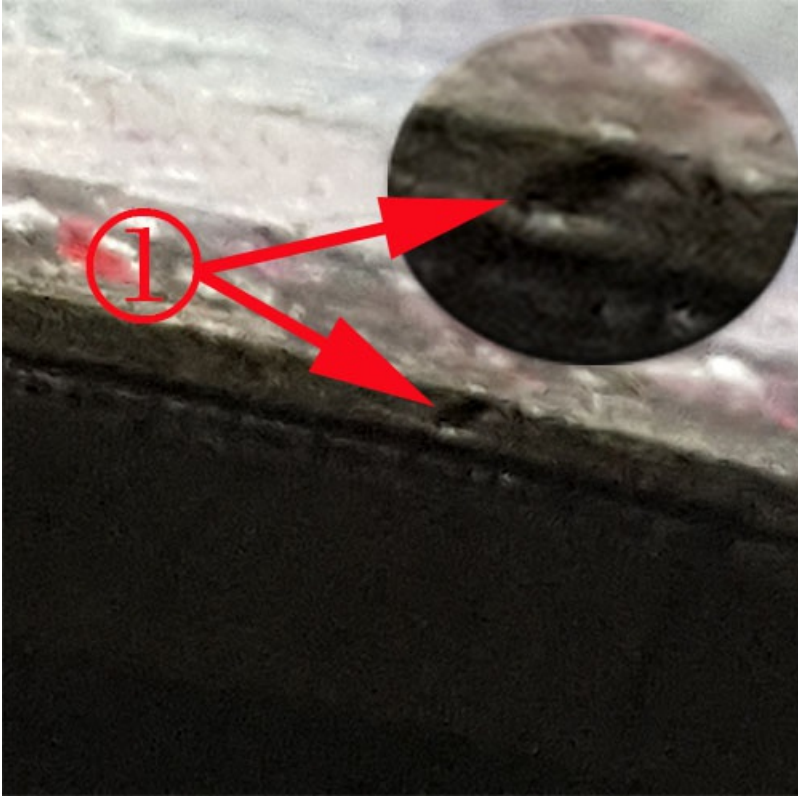
For coolant entry at the liner to deck face casting of the cylinder bore.

It is hard to see the actual source (pin hole) but it usually streams down the liner so that you can see it with a borescope.(Sometimes) The top of the piston will be steam cleaned.

Do not confuse residual fuel on the piston crown / surface as coolant. Some fuel residue may be present and can be mistaken as coolant (reason for the cooling system Dye to be added). Use black light to confirm the liquid is coolant. If this concern is present, do not replace the cylinder head because that will not repair this concern. Call PQC per the latest version of [16-NA-338](#), if required, reference this PI and replace the engine.
