Bulletin No.: PIC6194C Published date: 06/14/2017

PIC6194C (Malibu HEV) High Voltage Drive Motor Battery TAC Restriction and Exchange Program

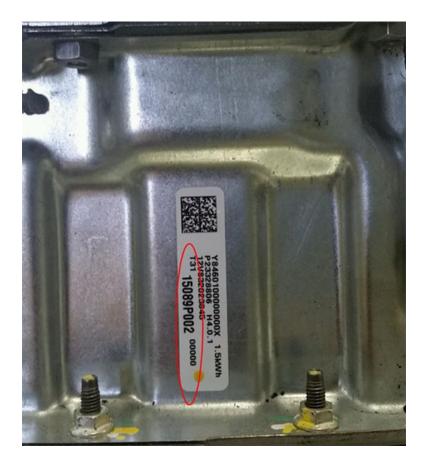
- 6.1 The battery has a battery identification tag that is located on the side of the battery. Locate the tag and record the 16 digit battery identification number (BIN). The BIN is the bottom most number on the label and it starts with a "T" indicator (See Photo Below). If the battery is not out of the vehicle yet, you can find the BIN by installing the MDI and using GDS 2. Access the Hybrid Powertrain Control Module 2 data list and look under the identification information section and the sixteen digit number will be listed under the parameter: Hybrid/EV Battery Pack Identification Number.
