Preliminary Information

PIT5404D Squeak Chirp Whistle Rattle Type Noise from Rear of Vehicle (Passive Exhaust Valve) or Buffeting Vibration Drone Exhaust Tone Change Body Pressure Booming (AFM Exhaust)

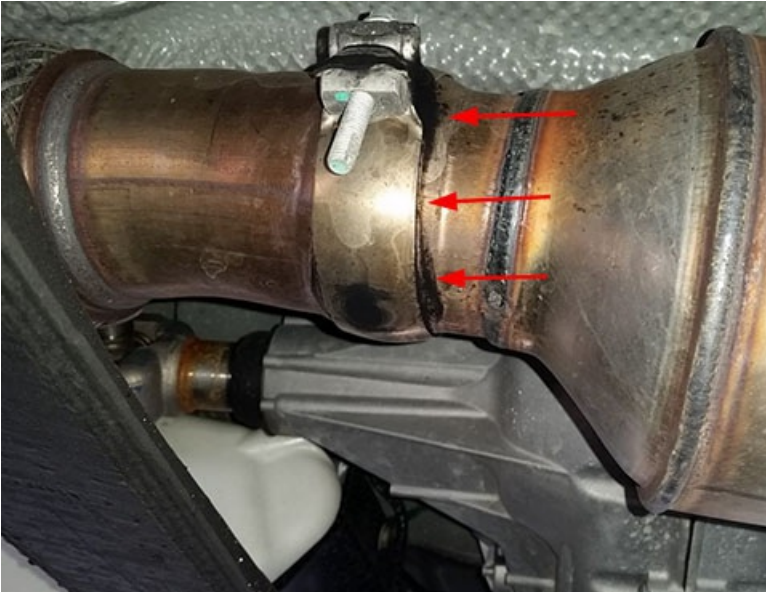
1. Ensure there are no leaks at the exhaust band (Norma) clamp joint. It has been found in some cases that a leak at the clamp joint could allow some level of exhaust tone change or exhaust vibration/drone type noise and/or buffeting vibration or body pressure booming to occur. Refer to latest version of [PIP5442](#).
