Preliminary Information

PIP5402A Check Engine Light MIL P015B, P1101 and /or P0101 Reduce Engine Power

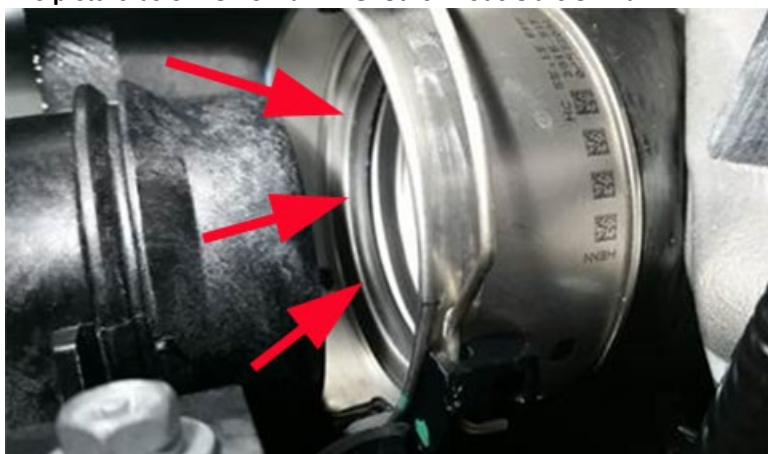
After following normal SI diagnostics, if a solution is not found, inspect for a missing/damaged O-ring seal in the charge air cooler coupler.

This coupler is located on the passenger side of the charge air cooler where the air duct slips into it.

The arrows in the picture below are pointing to the O-ring seal being discussed.

The picture below is from an ATS. Other models are similar.
